# Investigation of the Luxury Yachts Condition and their Maintenance

## 2. Investigation and testing of the luxury yacht's condition and its maintenance - real example

*Figure 1. Luxury yacht*

Table 2. Results obtained and recommendations

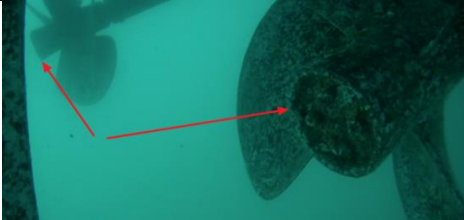
<p>CORROSION PROTECTION</p>

<p>Anodes: the situation with the anodes is not good. The anodes of the boutruster propellers are completely missing.</p> <p>RECOMMENDED (type A) The situation is similar with the trims – 1 out of 4 is missing, immediate installation of anode protectors in missing places is recommended</p> <p>Keel/hull joint : no deformities detected</p> <p>Hull to deck joint : no deformities detected</p> <p>Cockpit: good condition</p>
<p>TRIM TABS PORT AND STARBOARD</p>

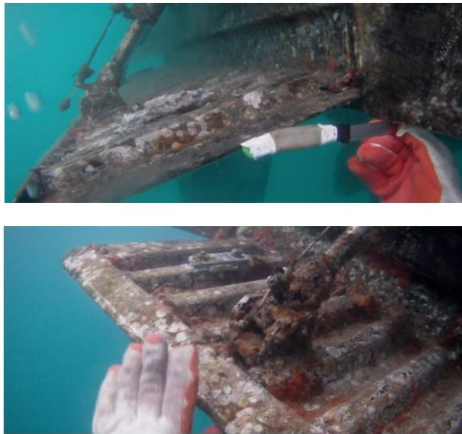
<p>–do not move do not work is not an unknown cause</p> <p>–both Stern Flaps are in place. No leakage noted around the hydraulic system, fixed in place by wires. Both flaps are fixed at 10 degrees to the waterline.</p> <p>– RECOMMENDED (type A2) quick repair is recommended. Nonfunctional trimmers significantly deteriorate the boat's seaworthiness to DANGEROUS levels in high winds and waves. They significantly reduce engine efficiency and increase fuel consumption.</p> <p>Anode protectors are missing and trimmers are highly at risk of rapid corrosion RECOMMENDED (type A2) quick installation of anodes is recommended - 4 pcs</p>

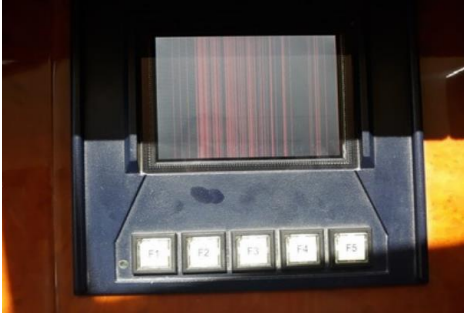
<p>ENGINE</p>

<p>Engine panel upper : MTU 16v 1850 hp</p> <p>Engine hours : Port : 870h -</p> <p>Starboard : 870h</p> <ul style="list-style-type: none"> <li>- left engine dashboard does not work</li> </ul> <p>RECOMMENDED (type A2) quick replacement with a new one is recommended</p> <ul style="list-style-type: none"> <li>- the right panel is in good condition</li> <li>- Engine beds: good condition.</li> <li>- Engine mounts Port and Starboard: good condition.</li> </ul>
<p>COOLING SYSTEM : PORT AND STARBOARD</p>

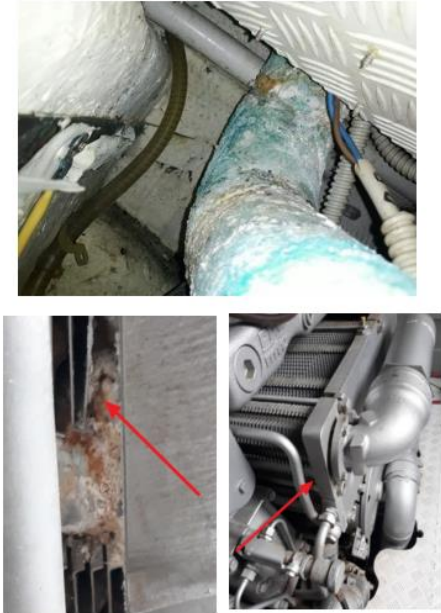
<ul style="list-style-type: none"> <li>- Basically the system is in good condition and the engines cool well</li> <li>- There is a disturbing leakage of salt water from a pipe which is part of (engine heat exchanger) is located between the engine and the exhaust transom outlet of the boat. RECOMMENDED (type A1)</li> <li>- Unacceptable corrosion, as the outlet is part of the bottom fittings and is actually below the waterline, and its failure makes it extremely DANGEROUS for the buoyancy of the boat, immediate troubleshooting is recommended.</li> <li>- Photos attached. The right engine system has the same problem.</li> </ul> <p>Exhaust system Port and Starboard: good condition</p> <p>Ventilation Port and Starboard: good condition</p>

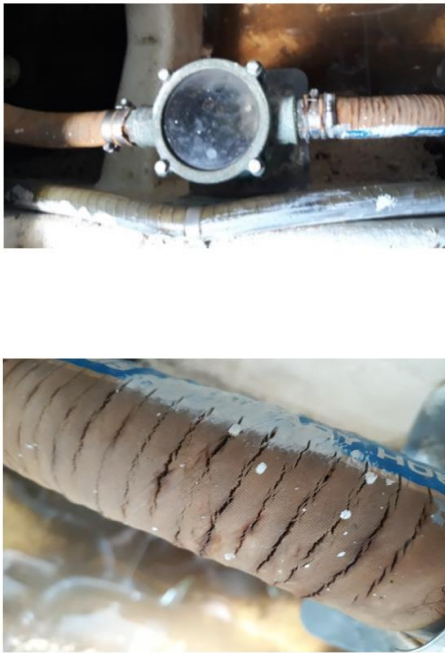
<p>The air conditioner starts but it doesn't work.</p> <ul style="list-style-type: none"> <li>- All four compressors cool. The tank that holds the fluid that is supposed to transport the cold water to each convector is LEAKY and does not hold fluid.</li> </ul> <p>Because of this, we could not make further tests on the convectors and the serviceability. RECOMMENDED (type B) sticking or replacing the tank!</p> <ul style="list-style-type: none"> <li>- Extremely dangerous hose in the air-conditioning system, located below the waterline before and after the coarse particles filter. The hose is with a metal coil, BUT it is already cracked and is very DANGEROUS. RECOMMENDED</li> </ul> <p>(type A1 ) as soon as possible the replacement of this hose must be arranged</p>
