FIELD PEDOLOGICAL CHARACTERISATION OF TWO TRANSECTS ALONG THE INNER AND OUTER SIDES OF A SIXTY YEARS OLD TISZA DIKE – A CONTRIBUTION TO THE PROBLEM OF PRIMARY AND SECONDARY ALKALI GRASSLANDS

TIBOR TÓTH¹ – ROGER LANGOHR² – JUDIT BECZE-DEÁK³ – ZSOLT MOLNÁR⁴

Abstract

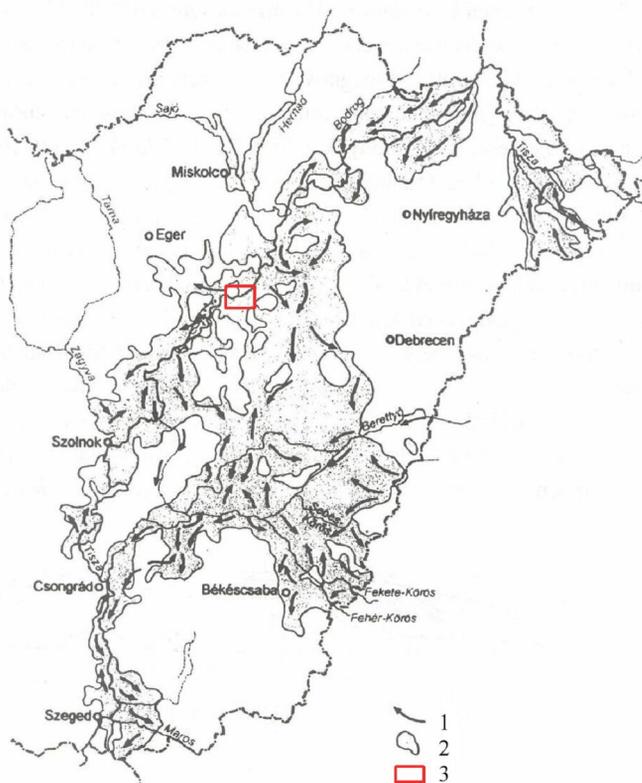
Fig. 1. Areas affected by floods before the large-scale diking in East Hungary. Taken from Ihrig (1952) and Schweitzer (2004). 1 = place and direction of flood water outbreak; 2 = inundated area, 3=study area.

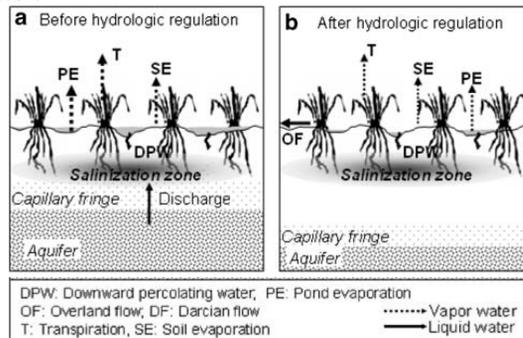
Fig. 2a–b. Conceptual model summarizing the range of hypothetical mechanisms which explain the salinization patterns observed in grassland before and after hydrological regulation. Before hydrological regulation (situation corresponding to the situation inside the dike) the water table was shallow enough to allow a discharge regime sustained by transpiration and a soil and river water evaporation leading to salt accumulation in the upper soil layers (a). After the hydrological regulation, (situation corresponding to the situation outside the dike) the water table was lowered and consequently the discharge regime interrupted, but the salts remained due to poor soil physical conditions (such as imperfect drainage and low permeability) preventing their total leaching (b). (Figure copied from Nosetto et al. 2007).

Our research hypothesis, presented in Fig. 2 is based on a lower groundwater level and a lesser degree of soil saturation outside the dike versus the inside area.

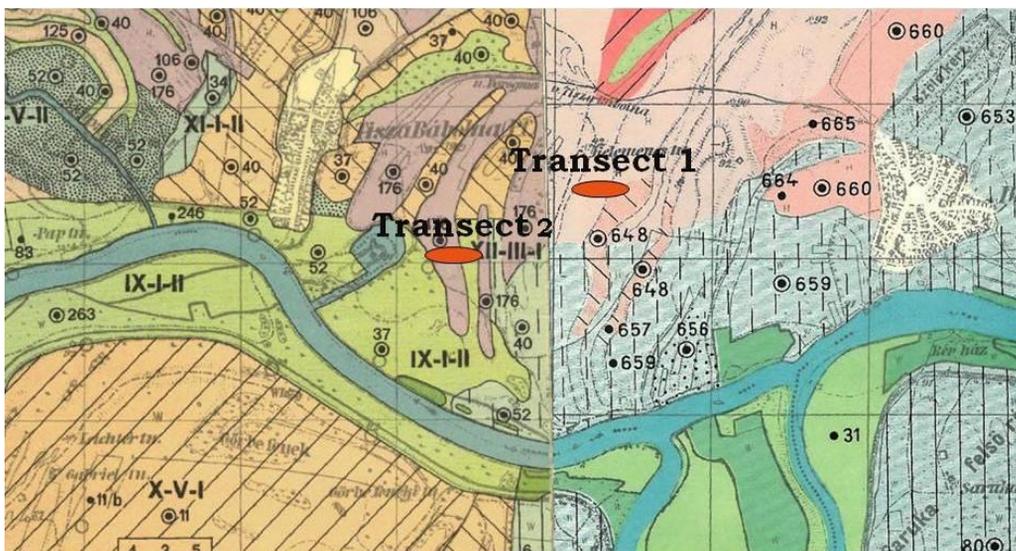
Fig. 3. The study area and the transects as shown by the soil maps (Kreybig, 1937). It can be observed that inside the bow of the river there are several roughly north-south oriented bended ridges which are covered by salt-affected soils, indicated by a purple colour.

Fig. 3 shows that there was no dike at the time of topographic survey. The soil mapping by the team of Kreybig (1937) was carried out by Zakariás (1942), right after the diking. Fig. 4 shows a distinct actual land use on the two sides of the dike (hay meadows inside, pastures and arable fields outside). Both inside and outside and parallel to the dike, west-east oriented transects were delineated towards the deeper eastern end, reaching temporary water bodies. Along the transects, plant coenological assessment (Molnár and Borhidi 2003, Table 2), soil bulk electrical conductivity measurements (ECa) (Rhoades and Van Schilfgaarde, 1976) (at each meter distance) and soil profile observations were carried out. On each transect, two shallow and one deep profiles were opened. With an auger all six profiles were studied down to the water table. Latter was sampled and its electrical conductivity (EC) and pH measured in the field with hand-held Horiba meters.

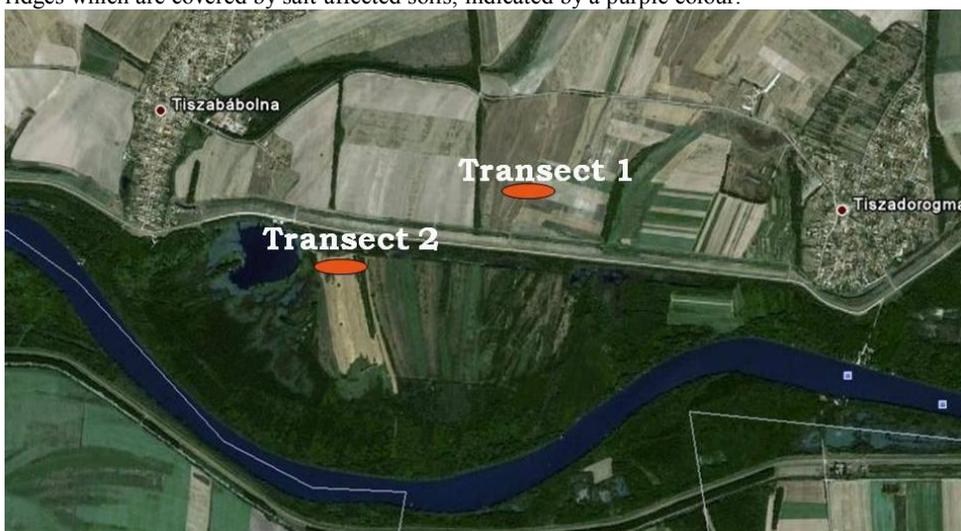
Fig. 4. The area as shown by SPOT image with the approximate location of the transects (Google Earth, 2009 August). The west – east distance covered by the image is ca 5500 m.

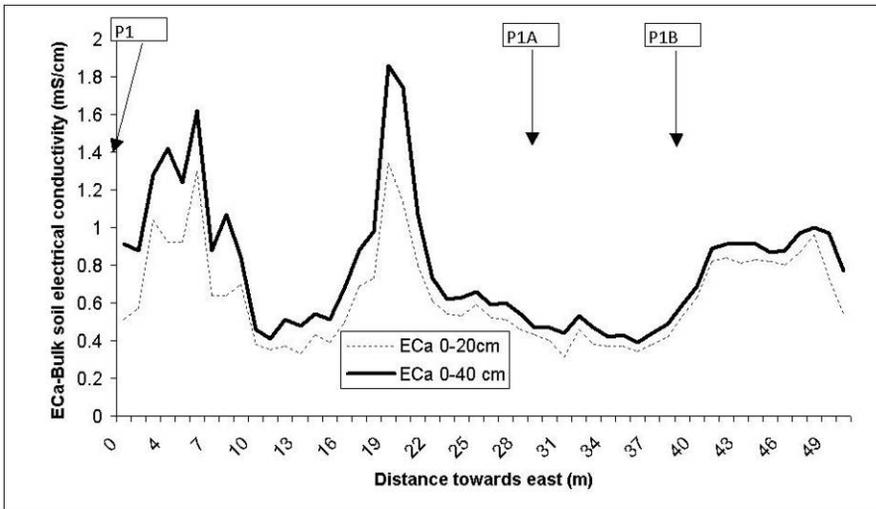
Fig. 5. Bulk soil electrical conductivity along Transect 1 (each meter) and the location of the profiles

Fig 5 shows the bulk soil electrical conductivity of Transect 1. From 42 m onwards there was standing water on the surface.

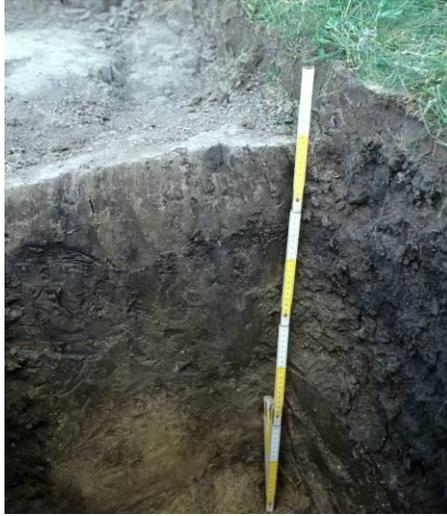
Fig. 6a. Profile 1. See Fig 7 for field sketch and Table 3 for the description of horizons.

Fig 6a and 6b shows Profile 1 (outside) and Profile 2 (inside the dikes) the landscape of transects outside and inside the dikes. Table 1 and 2 shows the parameters of groundwater (water table) and surface water sample.

This profile was considered as a reference for the first transect and more detailed descriptions were made. The field morphology of the observed characteristics is presented in Fig. 8a and 8b. First a general characterisation of the main horizons and a few particular observations will be presented. The systematic observations are described in Table 3.

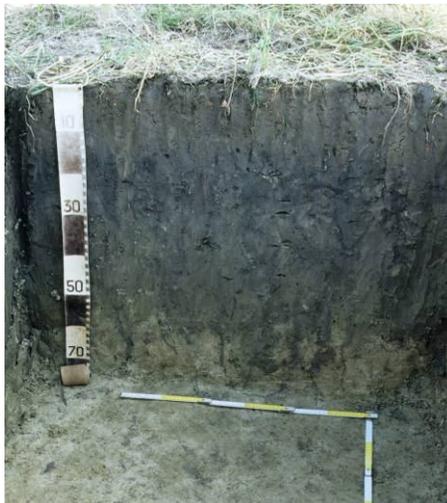
Fig. 6b. Profile 2. See Fig 11 for field sketch and Table 6 for the description of horizons.

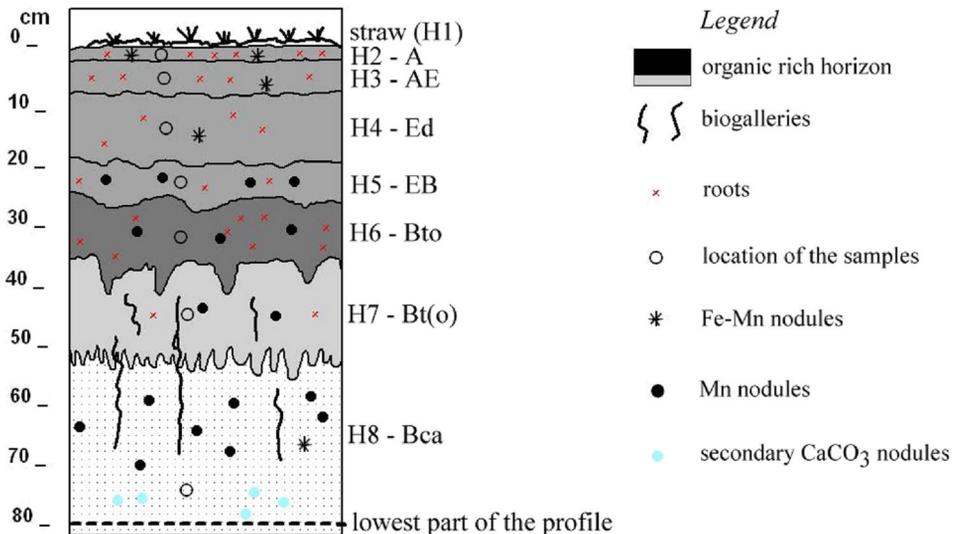
Fig. 7. Profile 1, field sketch, see also Fig 6a.

Profile 1 description (see Fig. 7).

- H1 Fresh straw.
- H2 Root mat with some mineral components.
- H3 Organic rich mineral horizon with abundant roots.
- H4 Light coloured, most probably eluvial horizon. Corresponds also to the densest part of a traffic pan.

- H5 Transition horizon. Corresponds also to the lower part of the traffic pan.
- H6 Very dark coloured horizon, most probably with clay and organic matter accumulation.

- H7 Transition horizon, with organic matter and clay accumulation.
- H8 Brown, horizon developed in loess-like sediments, calcareous.

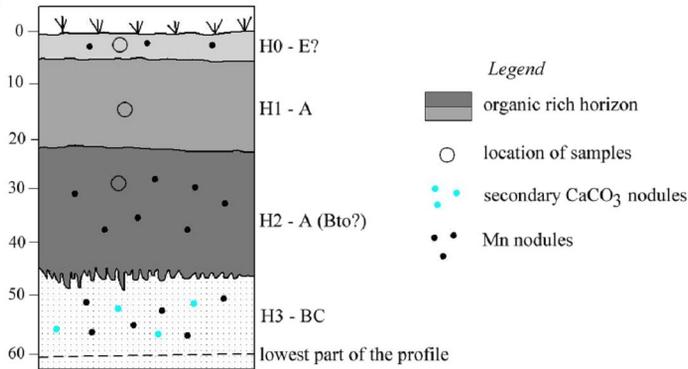
Fig. 8. Profile 1A, field sketch

Profile 1A description (see Fig. 8).

- H0 0-5 cm Seemingly an eluvial horizon. Coarse sandy material with few Mn concretions. Non-calcareous.
- H1 5-22 cm A Organic rich horizon, slightly lighter coloured than the underlying. No hydromorphy. Incomplete granular to angular blocky, no prisms observed. Roots go through the peds. Non-calcareous
- H2 22-46 cm A or Bto Strongly organic rich horizon, most probably as a result of clay and organic matter illuviation. Common up to 4 mm diameter Mn nodules. Non-calcareous.

- H3 46-60 cm BC Reaction with HCl. Common up to 8 mm diameter Mn nodules. Very dry character as H8 of Profile 1.

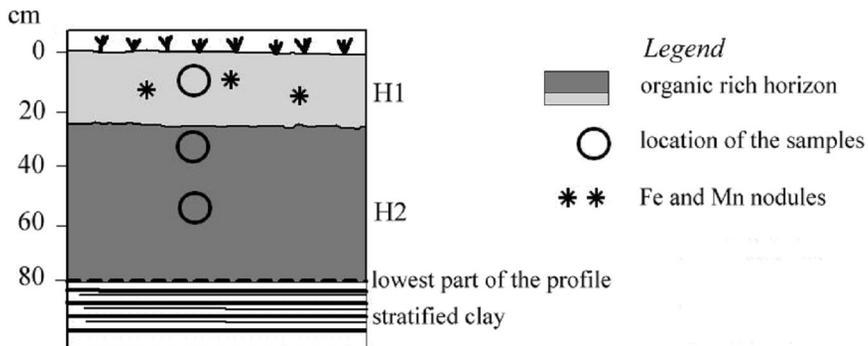
Fig. 9. Profile 1B, field sketch

Profile 1B description (see Fig. 9).

The upper 20 cm is water saturated from the surface; deeper it is more dry, indicating the presence of a perched water-table.

- H1 0-27 cm A Surface organic rich horizon, same as underlying one. Active reduction in the upper 10 cm. Slightly reduced matrix and abundant Fe mottling. Non-calcareous.
- H2 27-80 cm A(Bto) Very organic rich horizon. Up to 30-35 % clay. Almost complete granular (real Meadow soil). Non-calcareous.

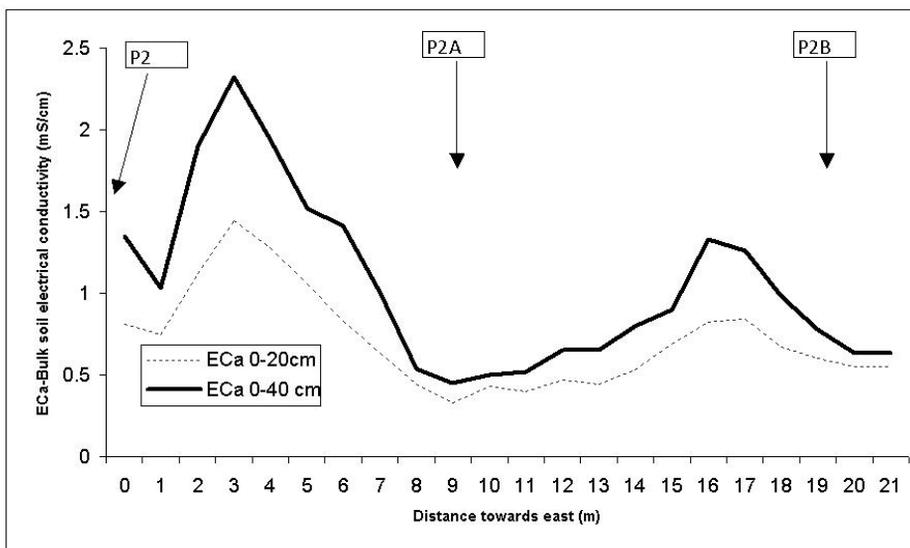
Fig. 10. Bulk soil electrical conductivity along Transect 2 (each meter) and the location of the profiles

Fig. 10 shows the bulk soil electrical conductivity of Transect 2. From 21 m onwards there was standing water on the surface. Table 4 and 5 shows the parameters of groundwater (water table) and surface water sample. In the case of Profile 2B the presence of slowly soluble salts in the suspended particles was suspected, which might have been dominated by sodium carbonate.

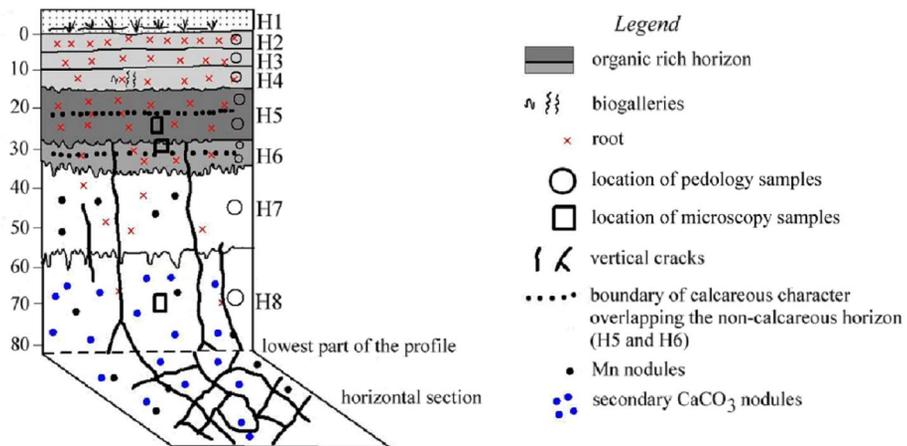
Fig. 11. Profile 2, field sketch, see also Fig 6b

This profile was considered as a reference profile for the second transect and a more detailed description was made. First a general characterization of the main horizons and a few particular observations will be presented. The systematic observations are described in the Table 6 below. Fig. 11 shows the field morphology of the profile.

Profile 2 description (see Fig. 11)

- H1 Straw layer with alluvial silt, non-calcareous.
- H2 Organic rich surface horizon with abundant root mat.
- H3 More reduced surface horizon.

- H4 Lighter coloured (eluvial?) horizon. Undulating lower boundary.
- H5 Very dark, organic rich horizon: The upper part is non-calcareous, while the lower part is moderately calcareous.
- H6 Transition horizon. The upper part is moderately calcareous, the lower part is weakly calcareous.
- H7 Brown horizon of decalcification.
- H8 Calcareous parent material with secondary CaCO₃ accumulations.

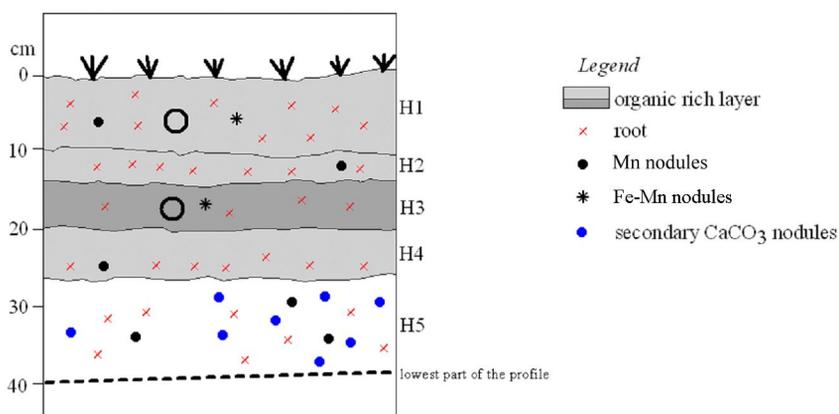
Fig. 12. Profile 2A, field sketch

Profile 2A description (see Fig. 12)

Thicker alluvial silt on top of the soil in comparison with Profile 2.

- H1 0-10 cm Root mat. 25 % clay; granular pedality.
- H2 10-14 cm Transition horizon. Good granular pedality.
- H3 14-20/23 cm Black, organic rich horizon. 35-40 % clay.
- H4 20/23-26 cm Transition horizon.
- H5 26-40 cm Calcareous subsurface horizon with common secondary CaCO₃ accumulations.

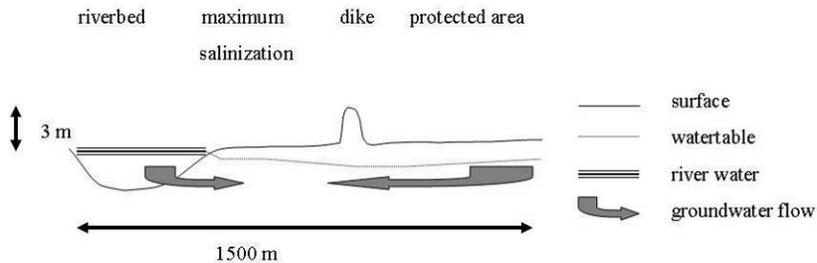
Fig. 13. The formation of a maximum salt-affected zone along the river Tisza

Our results support the basic hypothesis that the increasing build-up of the riverbed might contribute to the contrast in soil and groundwater salinity between the areas inside and outside the dike. Previously the river was cutting deep into the land surface providing an opportunity to carry some of the salt load of the upland groundwater flowing downwards into its bed. At present such transport is hampered since the river bed gradually filled up with sediments and less and less vadose groundwater is flowing into the bed position. This process can give clue to the higher salinity of the soils, the groundwater and the water observed inside the dike versus the outside position. Kuti (1989) presented a hypothesis on the formation of the salt-affected areas of Danube valley due to the groundwater traps. In his figure the surface of the salt-affected soil surface lies at 94 m, the top of the dike is at 96 m and the top of the sand ridge towards east is 130 m above sea level at the distance of 60 km away. These traps are formed under the effect of groundwater flowing from two directions: the river bed and the ridges. A similar mechanism can be

responsible for the increased salinity inside the dike in the case of river Tisza, as presented in Fig. 13.

In comparison with the sandy and strongly sloping Danube area, the Tisza study concerns silty and clayey soils that display low slope angles. The scale of the soil system dynamics is distinct too, the maximum distance between the dike and the river being 1.5 km, and the maximum difference in elevation between riverbank and topographic high reaching only 3 meters (Fig. 13).
