FIELD PEDOLOGICAL CHARACTERISATION OF TWO TRANSECTS ALONG THE INNER AND OUTER SIDES OF A SIXTY YEARS OLD TISZA DIKE – A CONTRIBUTION TO THE PROBLEM OF PRIMARY AND SECONDARY ALKALI GRASSLANDS

Keywords: Solonetz, pedology, soil morphology, soil formation, salinization, river regulation

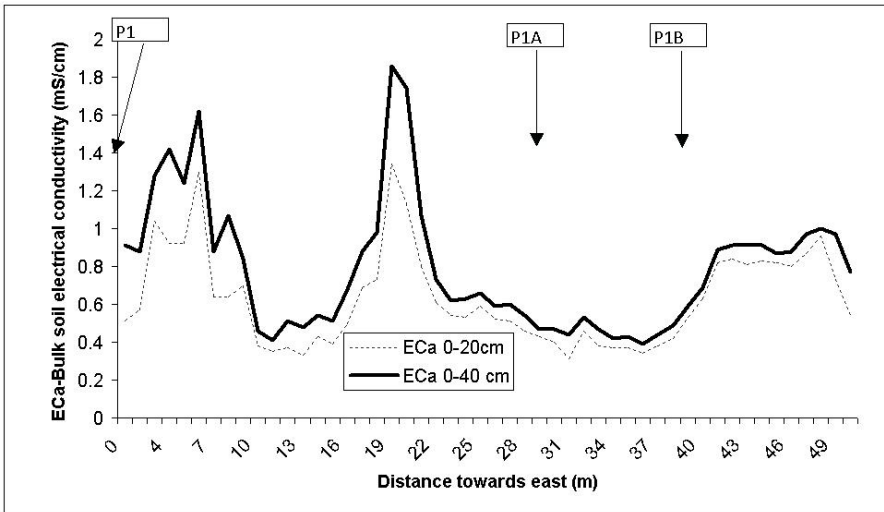
Fig. 5. Bulk soil electrical conductivity along Transect 1 (each meter) and the location of the profiles

Fig 5 shows the bulk soil electrical conductivity of Transect 1. From 42 m onwards there was standing water on the surface.

The mean ECa and its standard deviation (Fig. 5 and 10, Table 7) were higher inside the dike. Also the ranges of the semivariograms were shorter (7.5 m) inside than outside (9.5 m) the dike, indicating patches of distinct soil salinity with shorter diameter (the details of the semivariogram calculation are not shown).

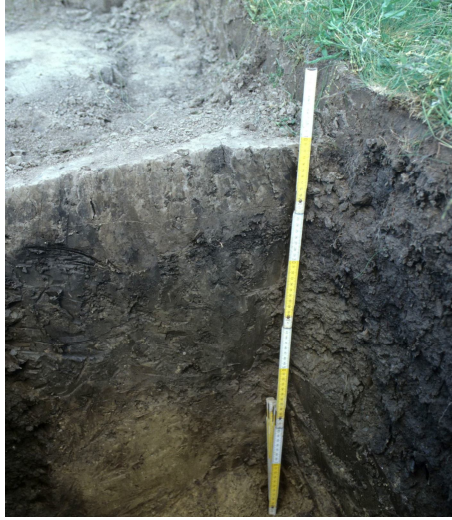
Fig. 6a. Profile 1. See Fig 7 for field sketch and Table 3 for the description of horizons.

Fig 6a and 6b shows Profile 1 (outside) and Profile 2 (inside the dikes) the landscape of transects outside and inside the dikes. Table 1 and 2 shows the parameters of groundwater (water table) and surface water sample.

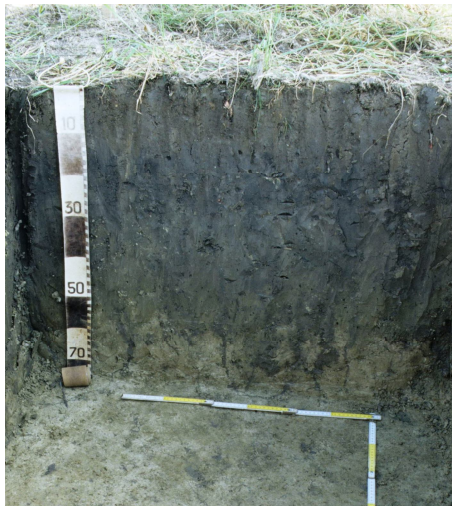
Fig. 6b. Profile 2. See Fig 11 for field sketch and Table 6 for the description of horizons.

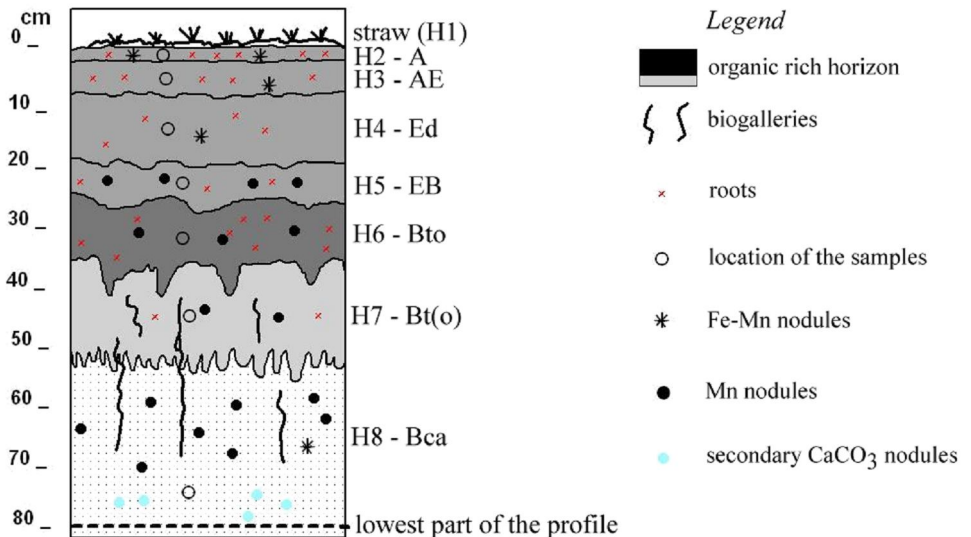
Profile 1 description (see Fig. 7).

- H1 Fresh straw.
- H2 Root mat with some mineral components.
- H3 Organic rich mineral horizon with abundant roots.
- H4 Light coloured, most probably eluvial horizon. Corresponds also to the densest part of a traffic pan.

patchy colours, ranging from very dark grey to very light grey (see Table 3). Compressed by puddling and/or machines. Silty accumulations along the ped faces from the overlying horizon. ECa 2.00 mS/cm.

- H5 Transition horizon. Corresponds also to the lower part of the traffic pan.
- H6 Very dark coloured horizon, most probably with clay and organic matter accumulation.

- H7 Transition horizon, with organic matter and clay accumulation.
- H8 Brown, horizon developed in loess-like sediments, calcareous.

Fig. 7. Profile 1, field sketch, see also Fig 6a.

Some soil characteristics such as the evidences of organic matter and clay migration and the structure indicate the presence of alkali conditions during the pedogenesis. These conditions however are not active anymore and these soil characteristics are degraded now. Most probably this landscape position is today a recharge area. These are landscape positions where an excess of rainwater percolates sufficiently deep through the soil to bring the soluble elements out of reach of the capillary rise to the surface. This is in contrast with the discharge areas with an accumulation of soluble elements in the surface soil horizons as result of an excess of capillary rise versus the downwards water movement.

The upper part of the soil is affected by compaction (plough pan), which is most probably the result of agricultural practices, such as cultivation and traffic by cattle when the soil is moist or wet. The prismatic structure starts at the upper part of H4 and is mainly affecting this horizon. This structure developed after the compaction and is due to the shrinking related to desiccation of such a dense horizon. Under this horizon the original granular structure is preserved. Generally very limited worm activity is observable at present.

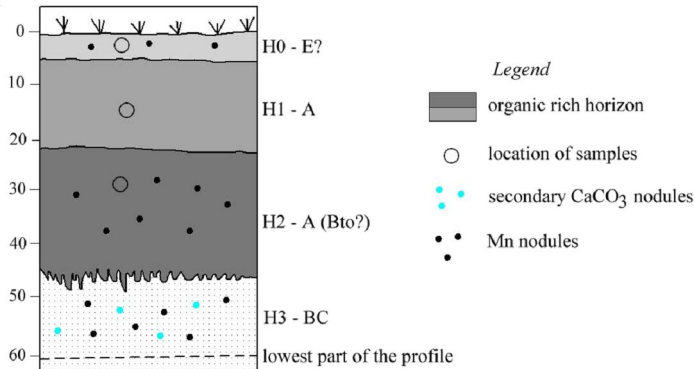
Fig. 8. Profile 1A, field sketch

Profile 1A description (see Fig. 8).

- H0 0-5 cm Seemingly an eluvial horizon. Coarse sandy material with few Mn concretions. Non-calcareous.
- H1 5-22 cm A Organic rich horizon, slightly lighter coloured than the underlying. No hydromorphy. Incomplete granular to angular blocky, no prisms observed. Roots go through the peds. Non-calcareous
- H2 22-46 cm A or Bto Strongly organic rich horizon, most probably as a result of clay and organic matter illuviation. Common up to 4 mm diameter Mn nodules. Non-calcareous.

- H3 46-60 cm BC Reaction with HCl. Common up to 8 mm diameter Mn nodules. Very dry character as H8 of Profile 1.

No puddling, no trampling and no densification features. The origin of the dark horizon can be attributed to the accumulation of clay and organic matter as a result of past alkali conditions. The “dry” feeling of H3 can be related to the processes discussed for H8 in Profile 1.

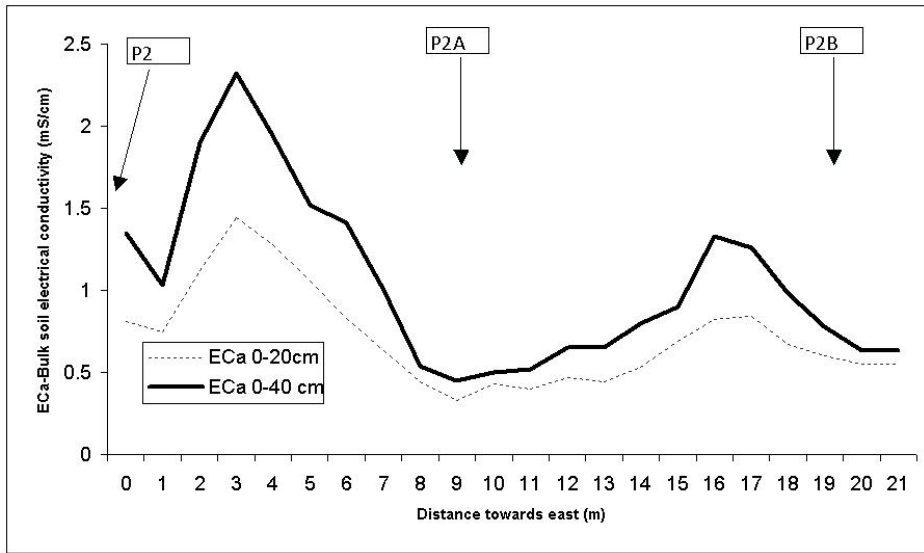
Fig. 10. Bulk soil electrical conductivity along Transect 2 (each meter) and the location of the profiles

Fig. 10 shows the bulk soil electrical conductivity of Transect 2. From 21 m onwards there was standing water on the surface. Table 4 and 5 shows the parameters of groundwater (water table) and surface water sample. In the case of Profile 2B the presence of slowly soluble salts in the suspended particles was suspected, which might have been dominated by sodium carbonate.

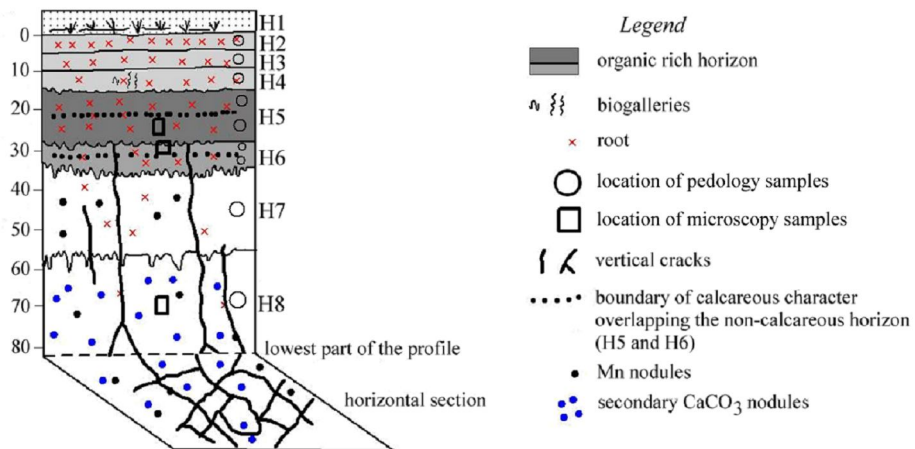
Fig. 11. Profile 2, field sketch, see also Fig 6b

Profile 2 description (see Fig. 11)

- H1 Straw layer with alluvial silt, non-calcareous.
- H2 Organic rich surface horizon with abundant root mat.
- H3 More reduced surface horizon.

- H4 Lighter coloured (eluvial?) horizon. Undulating lower boundary.
- H5 Very dark, organic rich horizon: The upper part is non-calcareous, while the lower part is moderately calcareous.
- H6 Transition horizon. The upper part is moderately calcareous, the lower part is weakly calcareous.
- H7 Brown horizon of decalcification.
- H8 Calcareous parent material with secondary CaCO₃ accumulations.

At 80 cm active polygonal pattern filled with organic matter coatings on the prism faces. This characteristic is not present in Profile 1.

The absence of humus-clay coatings and of slickensides (compare to Profile 1H6) is indicative of less pronounced alkali conditions in comparison with Profile 1. A particular aspect is the moderately to slightly calcareous character crossing partially H5 and H6. This might be related with a recalcification due to capillary rise and/or variability in the original sediments (see below).

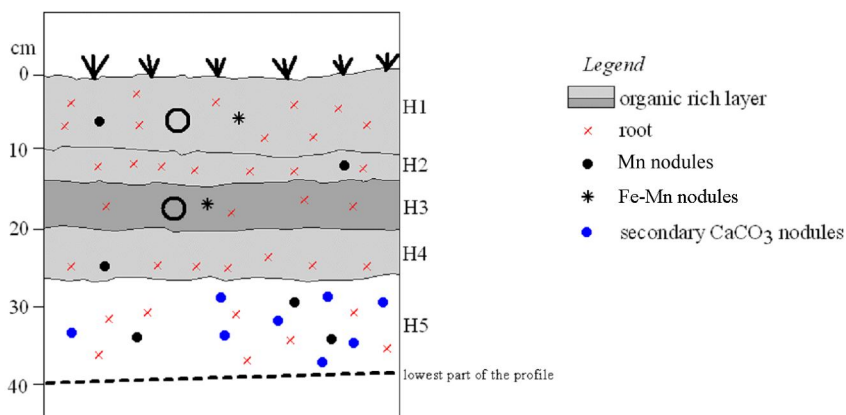
Fig. 12. Profile 2A, field sketch

Profile 2A description (see Fig. 12)

Thicker alluvial silt on top of the soil in comparison with Profile 2.

- H1 0-10 cm Root mat. 25 % clay; granular pedality.
- H2 10-14 cm Transition horizon. Good granular pedality.
- H3 14-20/23 cm Black, organic rich horizon. 35-40 % clay.
- H4 20/23-26 cm Transition horizon.
- H5 26-40 cm Calcareous subsurface horizon with common secondary CaCO₃ accumulations.

It presents similar characteristics as Profile 2, but less deep soil development. Interestingly, the ground water level was deeper than in Profile 2 (see Table 4). The

non-calcareous alluvial silty sediment (see Oroszi et al. 2005) on top of the soil is thicker in this landscape position as compared with Profile 2. More oxidised than Profile 2, and no greyish reduced horizon observed. The upper part of the soil is wet, water saturated, while the lower part is somewhat drier, but still wet. Common roots all through and in all the directions; very good root penetration. Abundant Fe-Mn nodules all through. Except H5, no reaction with HCl all through.
