THE DEVELOPEMENT OF RED MUD FLOOD ENVIRONMENTAL INFORMATION SYSTEM AND THE METHODOLOGY FOR THE SPATIAL ANALYSIS OF THE DEGRADED AREA

The red mud disaster occurred on 4th October 2010 in Hungary has raised the necessity of rapid intervention and drew attention to the long-term monitoring of such threat. Both the condition assessment and the change monitoring indispensably required the prompt and detailed spatial survey of the impact area. It was conducted by several research groups - independently - with different recent surveying methods. The high spatial resolution multispectral aerial photogrammetry is the spatially detailed (high resolution) and accurate type of remote sensing. The hyperspectral remote sensing provides more information about material quality of pollutants, with less spatial details and lower spatial accuracy, while LIDAR ensures the three-dimensional shape and terrain models. The article focuses on the high spatial resolution, multispectral electrooptical method and the evaluation methodology of the deriving high spatial resolution ortho image map, presenting the derived environmental information database.

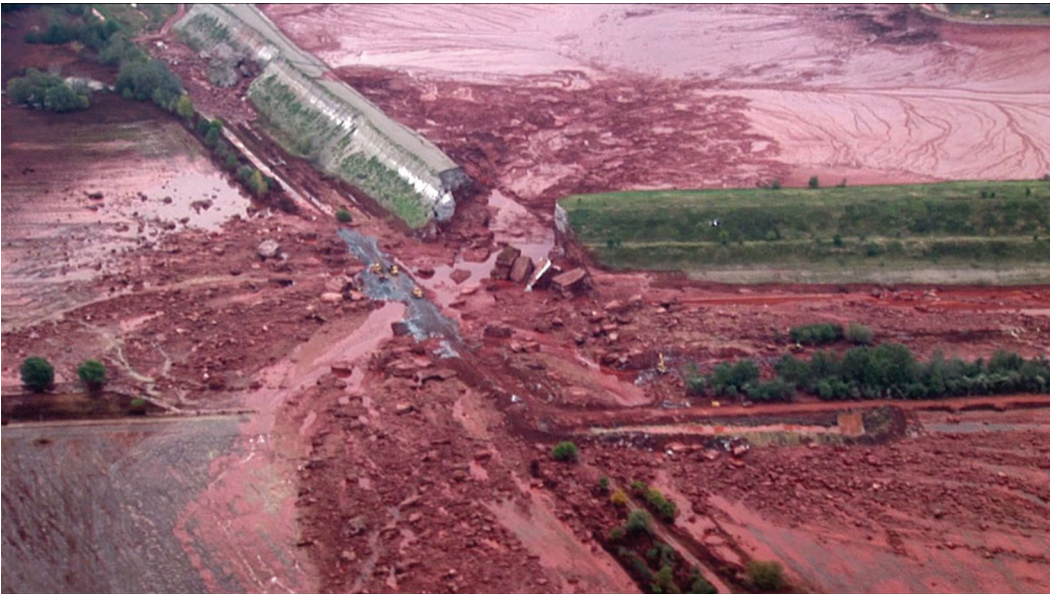
Fig. 1. The reservoir on 06th October 2010

of shear stress concentrated – near Kolontár settlement (Hungary) has cracked and broke (Fig. 1.). The rapidly flowing red mud flood affected the inner area of Kolontár and Devecser (Fig. 2.) causing injury to 150 people and killing 10 people. Outside of the inhabited areas the catastrophe has caused significant damages in wildlife (Fig. 3.). Most of the casualties have been suffered first or second degree burns caused by the alkaline ingredients of the mud flow.

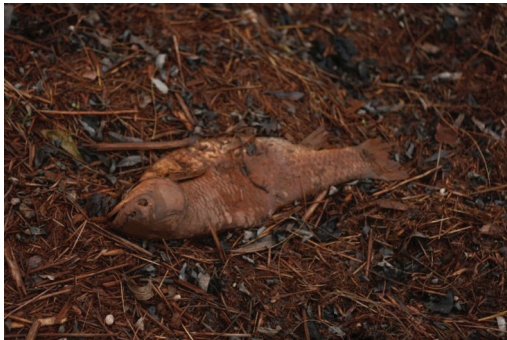
Fig. 3. The disaster damaged the wildlife as well: this dead fish was 10 meters from Torna Stream.

Deer footprints in the red mud

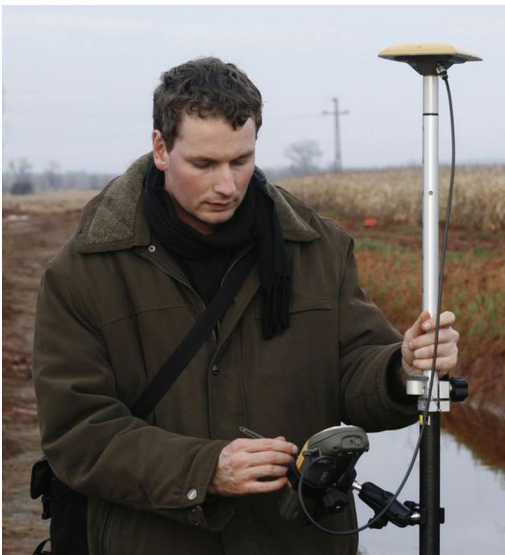
Fig. 6. Fieldwork on the contaminated area using geodetic GPS

Creation of accurate map required the collection of ground control points (GCPs). During a one week long fieldwork, the team collected 421 GCPs with 1.5 cm horizontal and 5 cm vertical accuracy (Fig. 6) for orthorectification and for accuracy analysis. These points in addition to the calibration data of camera system were necessary to process the true color (RGB) and multispectral images, correct distortions and georeference them.

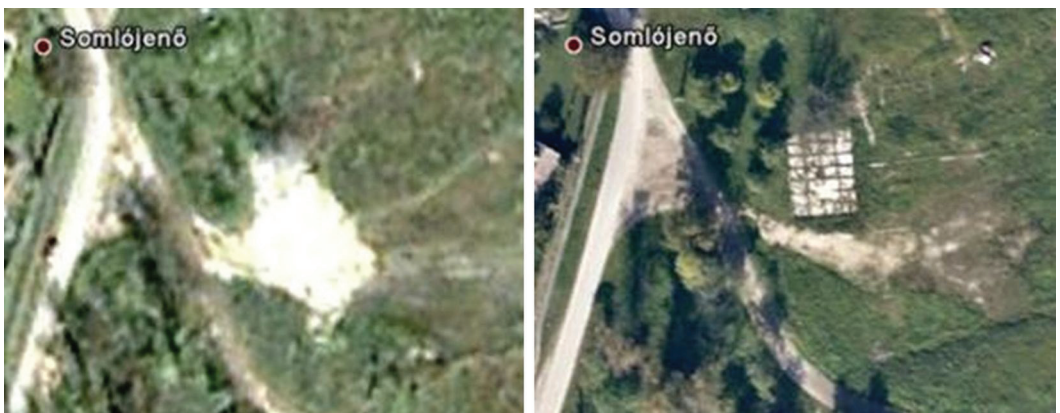
Fig. 7. Google Earth section is on the left while on the right the aerial image made with IS 2 system is presenting the same area reduced to the same resolution

of the high topographic accuracy, and our aim was to produce more accurate map than the available satellite images and the hyperspectral aerial mission. If the spatial resolution is higher, the GCPs can be identified more precisely. The surveying speed (ground speed of the flight) and the spatial resolution of our products are not the only development that makes them better than previous topographic maps and other aerial and satellite surveys; their density, hues also offers substantially wider range of visual interpretation and classification methods as (Fig. 7.) illustrates.

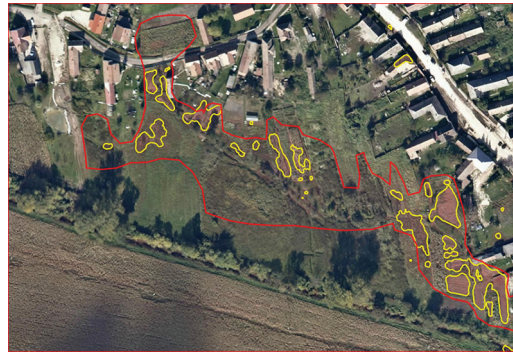
■ Visual interpretation	15573 m ²
■ Classification	26695 m ²
Difference	12878 m ² , 81,69%

Fig. 10. Visual interpretation classified formerly mudded patches as flooded area

However, in some part of the image map just the opposite could be observed. The classification detected the state of the red mud at the time of the recording, because the receded mud (flooded the area on the preceding days) reflected differently in color and texture in the image. Contrarily, the visual interpretation classified also those sections to the flooded area, where it seemed the mud had been there formerly; for example on the sample area (Fig. 10.) where the mud passed through, but did not accumulate. In similar areas the difference between the classification and the visual interpretation methods is much larger, in this case 81.69%. The re-

sult of visual interpretation is 15 573 m², the corresponding classification's polygon of the same area is 26 695 m². But the size of these sub-areas is minimal; the failures were corrected by vector relocation manually.

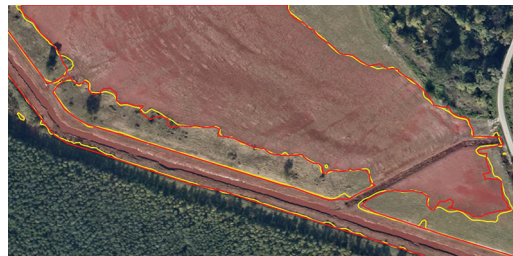
■ Visual interpretation	32630 m ²
■ Classification	32647 m ²
Difference	17 m ² , 0,05%

Fig. 11. Difference between the two interpretation methods.

In this 66 345 m² sample area (Fig. 11.) the visual interpretation resulted in 32 630 m² flooded area, while by classification the result was 32 647 m². The 17 m² difference corresponds to 0.05% in this case. On Fig. 11. this minimal difference is shown.

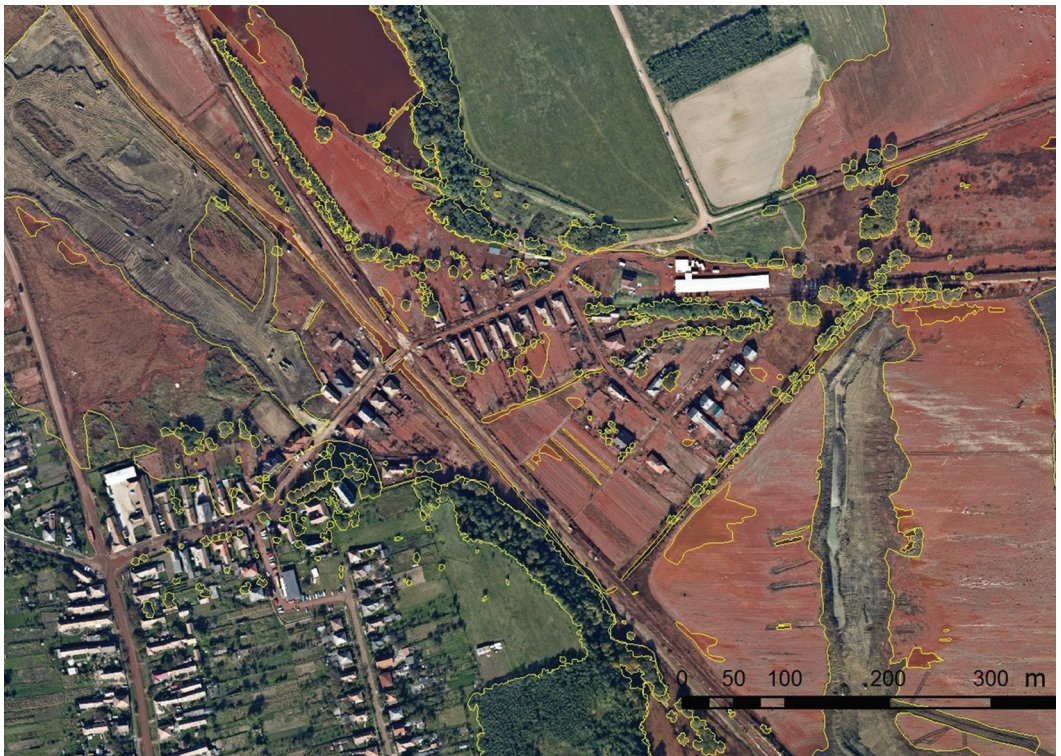
Figure 13. Flooded part of Kolontár in the geographic information system

time the deposited red mud has been removed from 147 322 m². On that time 1,285 buildings have stood in Kolontár and Devecsér on 238 835 m² area (by analyzing the aerial survey with visual interpretation). Among them 450 buildings (on 69 136 m² total area) have been affected directly by the flood. This information promotes the estimation of damages as well as the ecologic modeling. The flooded area covered by ligneous vegetation is 411 295 m² that means 2 287 groups of trees (by analyzing the aerial survey with classification). An overview map made using the created database seen on Fig. 12. The flooded town of Kolontár is seen on a superposition of aerial image map and vector layer evaluated by visual interpretation. By presenting the disaster-hit area the team has aimed at providing help and drawing attention to the prevention of such industrial disasters. The published data was useful for the disaster management and the emergency management groups working in field (Katasztrófavédelem.hu 2014).
