# LONG-TERM ANALYSIS OF RIVER TISZA WATER LEVEL DATA WITH REGARD TO THE ECOLOGICAL WATER DEMAND OF FLOODPLAIN WATER BODIES

## Abstract

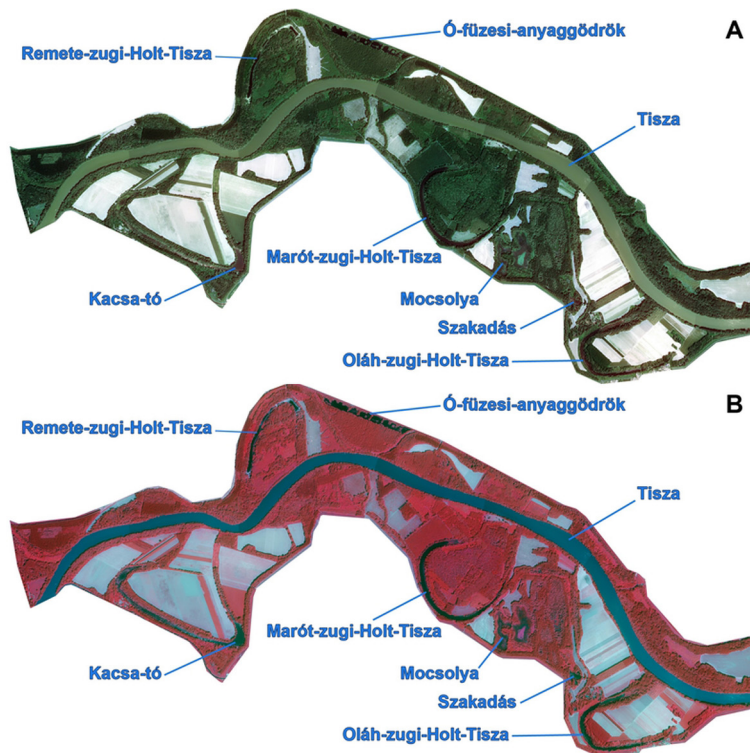
Fig. 1. Real (RGB, 1.A.) and false (NIR, 1.B.) colour composite image (© Envirosense Hungary Kft.) of the sampled area, the River Tisza floodplain on both sides between the settlements of Tiszabercel and Gávavencsellő, with the indication of the studied water bodies

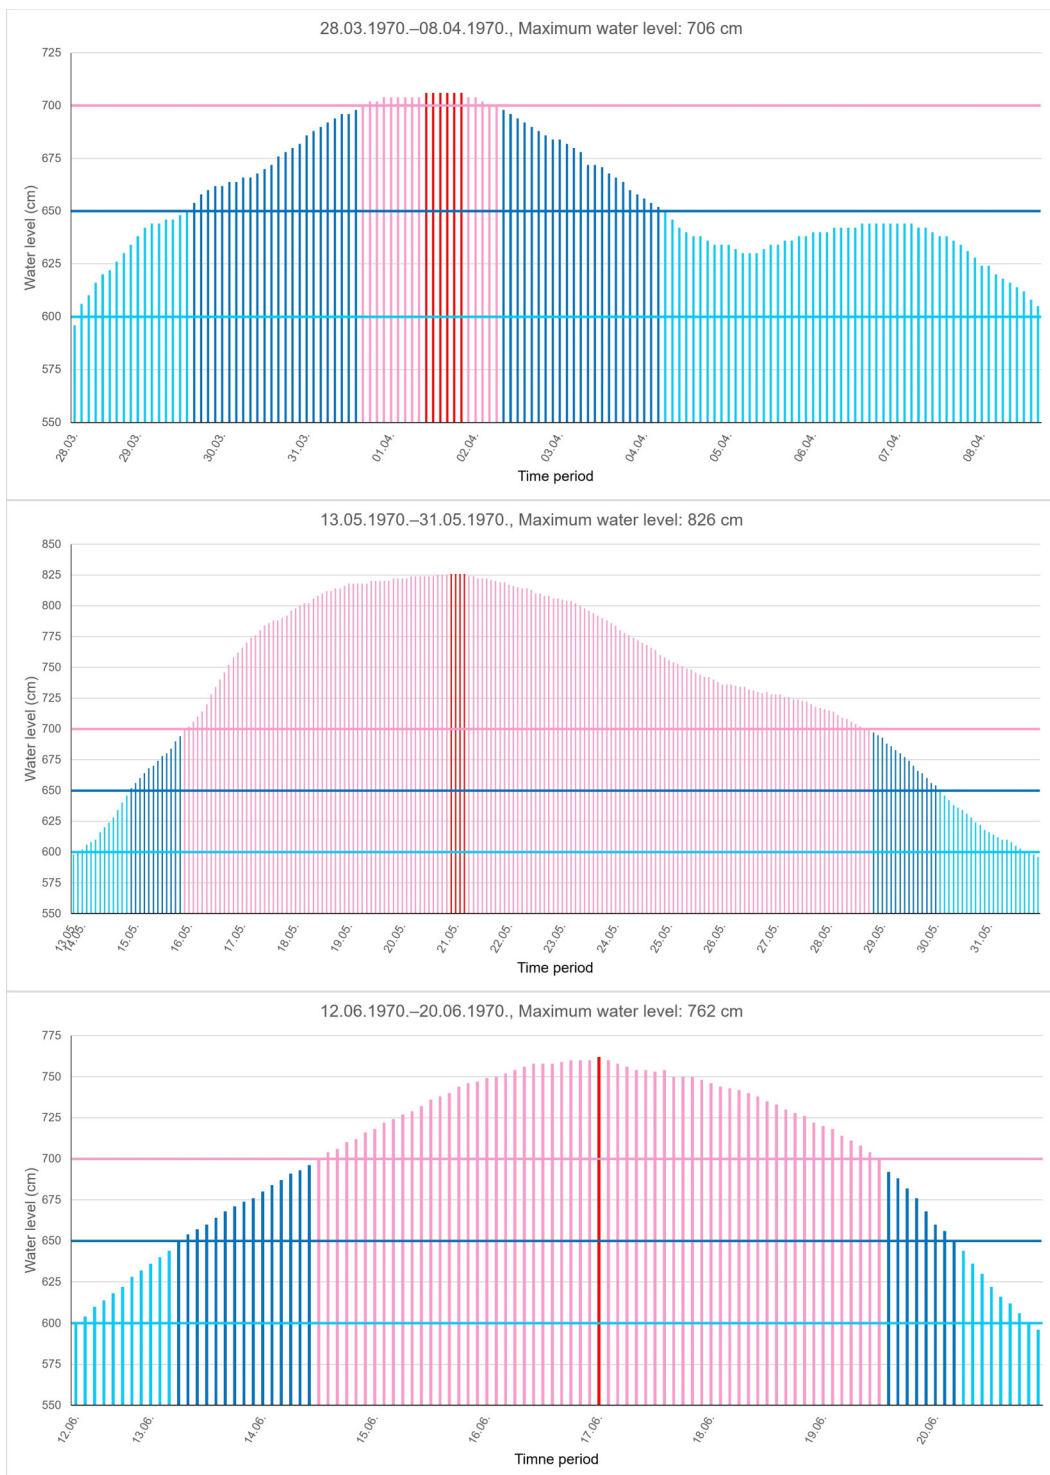
Fig. 2. Illustration of the evaluation of water level values at the Tiszabercel water meter exceeding the 600 cm water level in three periods of 1970

Based on all this, we collected values from the Tiszabercel water meter data which values are above 600 cm (97.36 mBf), broken down daily and every two hours from 1969 to 2019. The 1969 start date was chosen to allow for a coordinated assessment of events over a longer period. The evaluation and processing of the work are presented by the example of the 1970's data (Figures 2.). For each year, we plotted water level values exceeding 600 cm in that year, which can be even more times in one year, for example, in 1970 such a situation occurred 3 times

(Figure 2.). In the tables, the values between 600 and 649 cm are marked with light blue, those which are between 650 and 700 cm are marked with dark blue, those which starting from 700 cm are marked with pink and peaks with red. The same colouring is applied to the graphs showing values above 600 cm.

For example with the analysis of the data from the first chart of 1970 shows that between March 28 and April 8, the water level exceeded 600 cm through 12 days. The curve is elongated and double-peaked, with the maximum water level at the first peak at 706 cm. From this exemplary figure and data set presented as a table, it can be concluded that no significant and prolonged flooding occurred in the area at the early spring (the water level was above 700 cm for only around 38 hours).

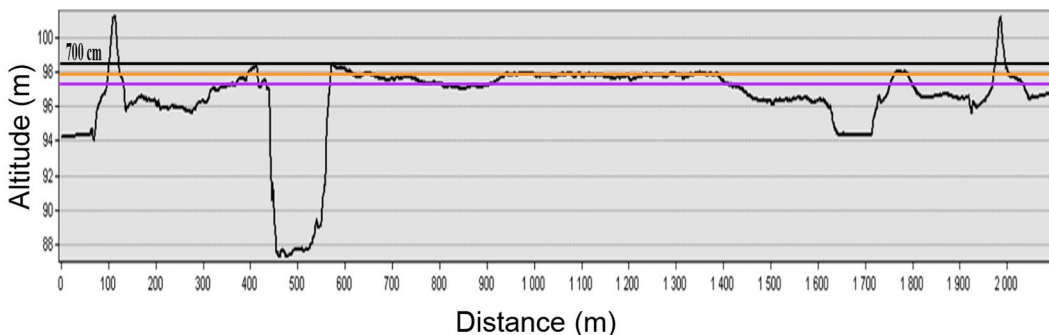
Fig. 3. A cross-section of the sample area that passes through the Marót-zugi floodplain, with indication the category boundaries of the flood waves analysis (purple: 600 cm; orange: 650 cm and black: 700 cm) (based on data provided by FETIVIZIG, modified version)

Figure 3. shows a cross-section of the floodplain through the River Tisza and the Marót-zugi-Holt-Tisza, as one of the sampled areas. The well-studied flood levels convincingly show that the complete flooding of the Marót-zugi-Holt-Tisza can only be expected at flood waves exceeding 700 cm. Based on the median values of the last half-century, it can be concluded that the maximum of the average values is quite far from the actual flood levels that causing flooding. The minimum of the average values is under the bottom level of the backwater (Fig. 4.).

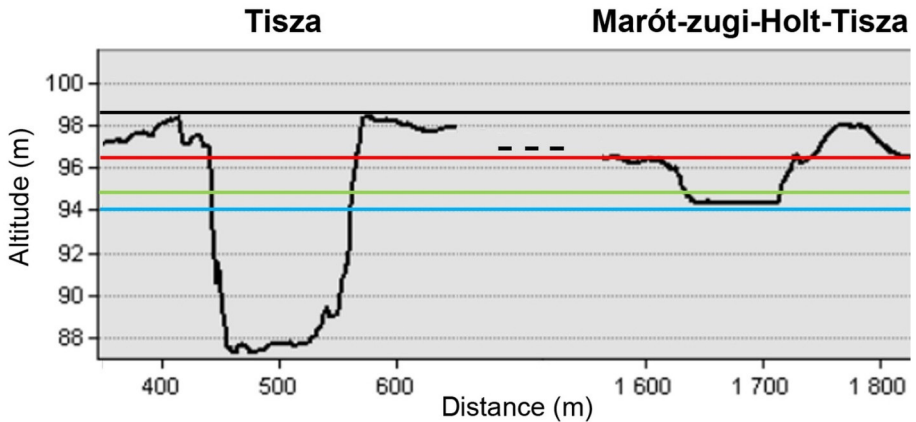
Fig. 4. Virtual saturation of the River Tisza and Marót-zugi-Holt-Tisza, based on the 48-year average values of the characteristic water levels (blue: minimum; green: medium; red: maximum and black: 700 cm) (based on data provided by FETIVIZIG, modified version)

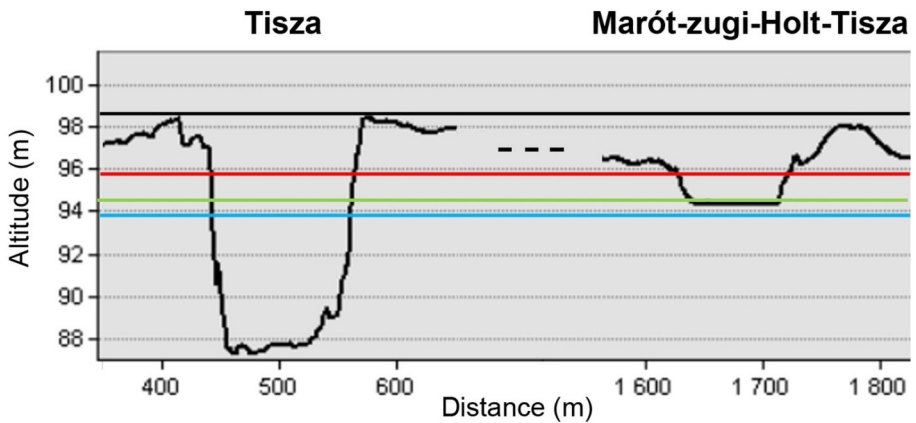
Fig. 5. Virtual saturation of the River Tisza and Marót-zugi-Holt-Tisza, according to the average values of the water levels typical in 2018 (blue: minimum; green: medium; red: maximum and black: 700 cm) (based on data provided by FETIVIZIG, modified version)

them in a little more detail in the case of Marót-zugi-Holt-Tisza (Fig. 5-8.). In 2018, water level exceeding 600 cm did not occur, so the backwater left without water replenishment. In 2019, water level exceeding 600 cm for only 6 days, and the peak was relatively low (678 cm) (Table 1.). Thus, this also resulted in only a partial water replenishment, mainly from the lower areas of the Marót-zugi-Holt-Tisza and through the Mocsolya (through a ditch for drainage and a canal connecting the Mocsolya with the Marót-zugi-Holt-Tisza). The annual average values (Figures 5. and 7.) and the annual daily extreme values (Fig. 6. and 8.), the average water level was close to the bottom level of the backwater in both years or coincided with that, and the minimum water level proved to be below the bottom level.

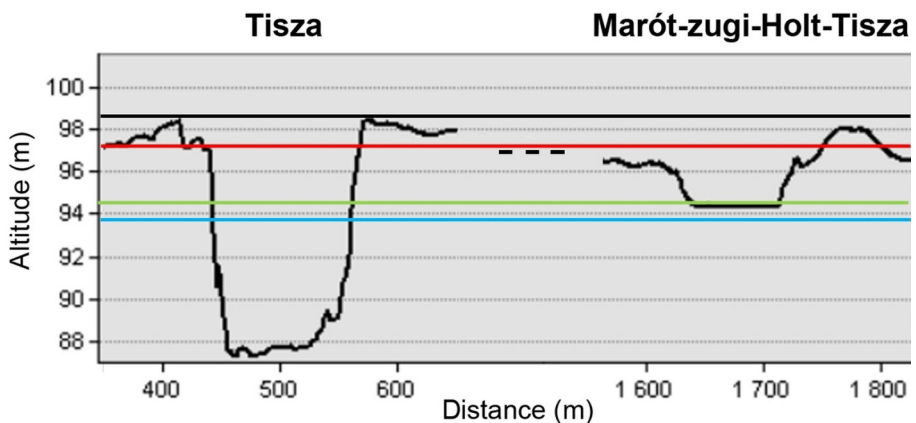
Fig. 6. Virtual saturation of the River Tisza and Marót-zugi-Holt-Tisza, according to the daily extreme water level values observed in 2018 (blue: minimum; green: medium; red: maximum and black: 700 cm) (based on data provided by FETIVIZIG, modified version)

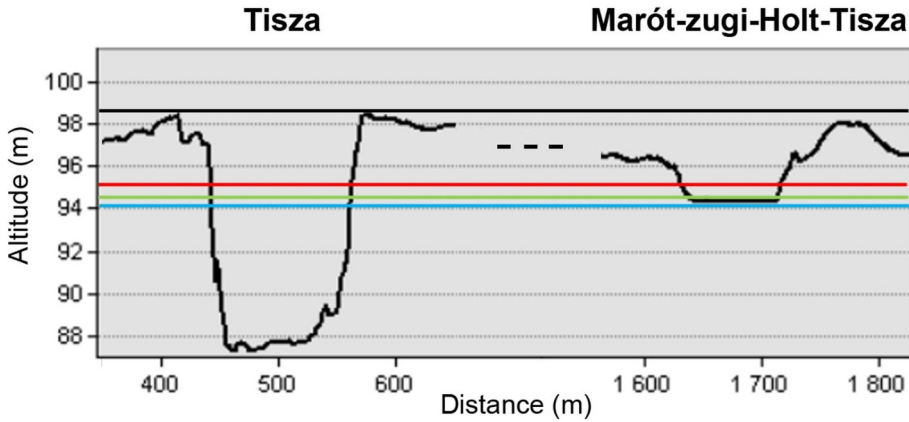
Fig. 7. Virtual saturation of the River Tisza and Marót-zugi-Holt-Tisza, according to the average values of the water levels typical in 2019 (blue: minimum; green: medium; red: maximum and black: 700 cm) (based on data provided by FETIVIZIG, modified version)

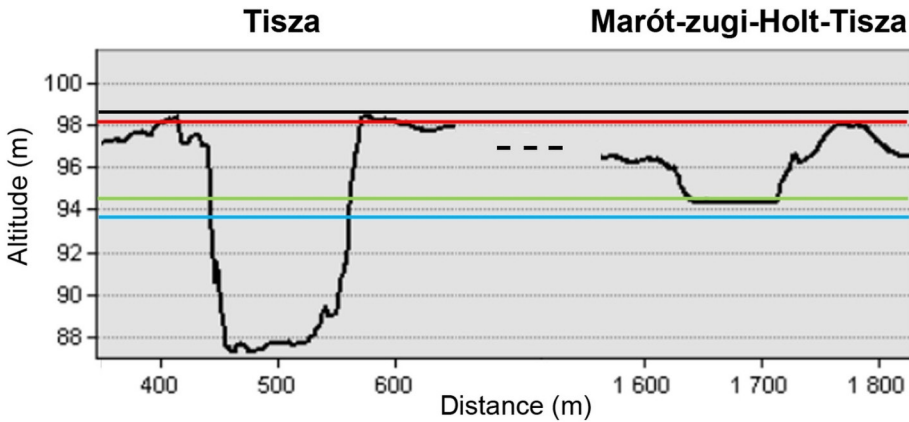
Fig. 8. Virtual saturation of the River Tisza and Marót-zugi-Holt-Tisza, according to the daily extreme water level values observed in 2019 (blue: minimum; green: medium; red: maximum and black: 700 cm) (based on data provided by FETIVIZIG, modified version)

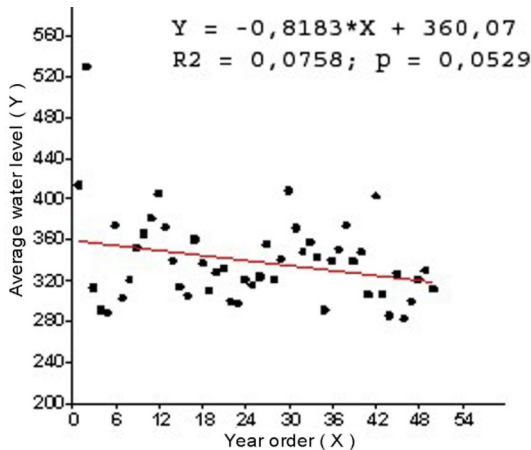
Fig. 9. Changes in the water level of the River Tisza based on the annual averages of the period 1969-2019, using the data series of the Tiszabercel water meter (based on data provided by FETIVIZIG, modified version)

Looking at these conditions, we also considered it necessary to examine the water yield of the River Tisza. We analysed in detail the changes in the water level of the river over time based on the 50-year (1969–2018) data series of the Tiszabercel water meter. The nature of the water level change was determined from the mean values by linear regression analysis using the OLS method (since the seasonal data have no error). The trend in the changes of the average values has a decreasing tendency, but in the examined period the correlation is only marginally significant (Fig. 9.). Taking into account the climate change scenarios for the River Tisza-Great Plain, it is highly probable that due to

the increasing water demand, this decreasing trend will continue even in this section of the river, presumably to a greater extent than before.

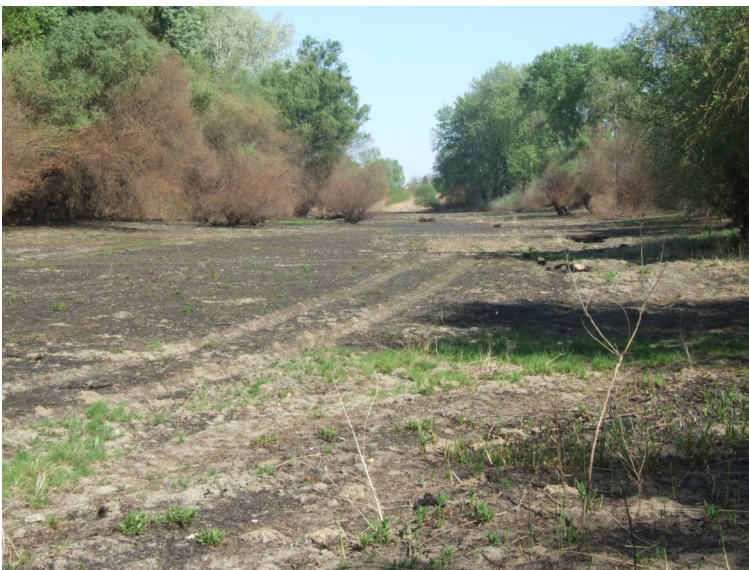
Fig. 10. The river bed of the dried out and scorched Oláh-zugi-Holt-Tisza in the spring of 2019 (Photo: György Dévai, April 20, 2019)

Taking into account the current terrain conditions, it can be stated that, similarly to the Kacs-tó, there is no favourable external water replenishment opportunity in the other water bodies too. Moreover, in some cases, drainage ditches ensure that the amount of water entering during major floods is drained as soon as possible. Because of this, the water that may remain inside the water bodies after the floods does not prove to be long-lasting. By the spring of 2019, for example, the Oláh-zugi-Holt-Tisza and the Szakadás were completely dried out (Fig. 10–11.), the vegetation in the riverbed was getting on fire

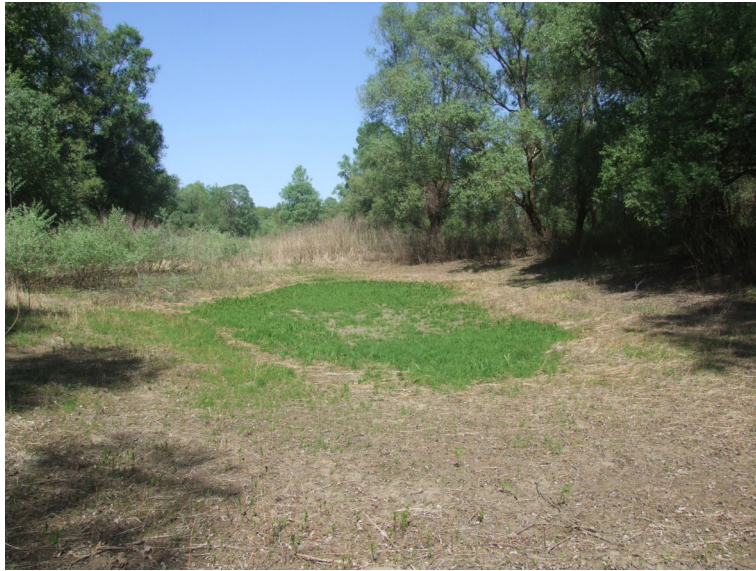
Fig. 11. Dried out river bed of the Szakadás in the spring of 2019 (Photo: György Dévai, April 20, 2019)

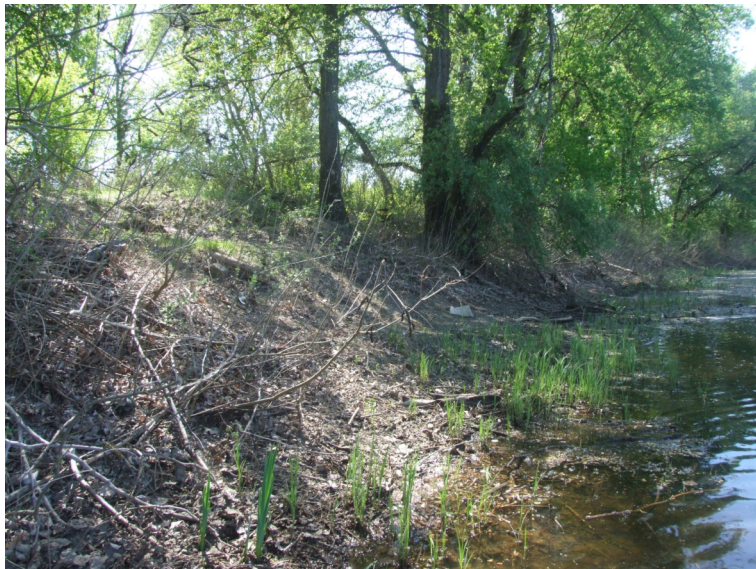
Fig. 12. The huge amount of water missing from the Marót-zugi-Holt-Tisza can be seen in the spring of 2019 (Photo: György Dévai, April 20, 2019)

and even the shoreline was scorched. There was hardly any water in the Mocsolya, and the water level in the Marót-zugi-Holt-Tisza was at least 1.5 m lower than before (Fig. 12.), which is also confirmed by the dried-out channel connecting the Mocsolya (Fig. 13.).

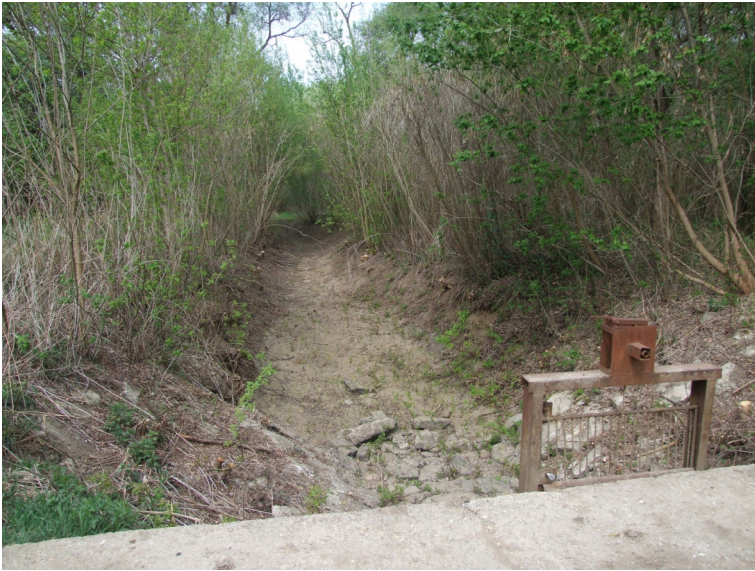
Fig. 13. The dried-out canal between the Marót-zugi-Holt-Tisza and the Mocsolya in the spring of 2019  
(Photo: György Dévai, April 20, 2019)
