A GIS-BASED STUDY ON THE CHANGING COURSE OF THE RIVER JIADHAL IN THE DHEMAJI DISTRICT, INDIA

PRANAMEE GOGOI

Department of Geography, L.T.K. College, Assam, India
Email: gogopranamee30@gmail.com

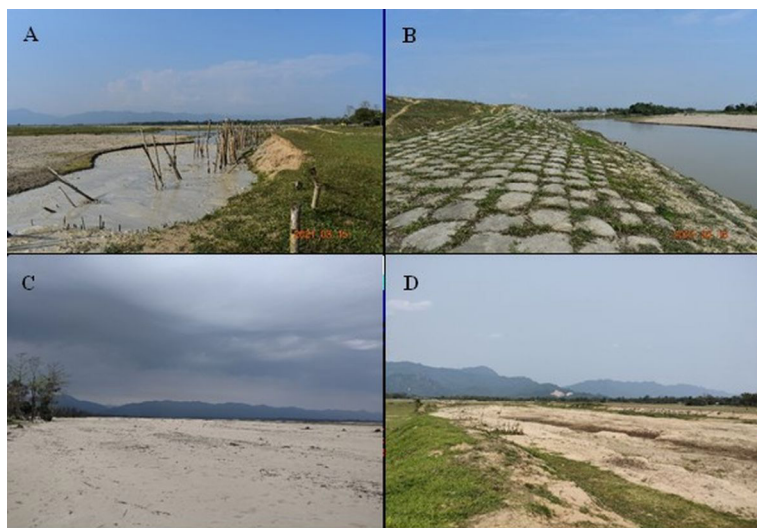
A. Protecting the river bank using bamboo, B. Protecting the embankment using geotags
C. Sediment Deposition within the river bed, D. An abandoned channel of the river Jiadhal
