ACTIVE POINT BAR DEVELOPMENT AND RIVER BANK EROSION IN THE INCISING CHANNEL OF THE LOWER TISZA RIVER, HUNGARY

Abstract

Keywords: point-bar development, bank erosion, incising channel, human impact, Lower Tisza River

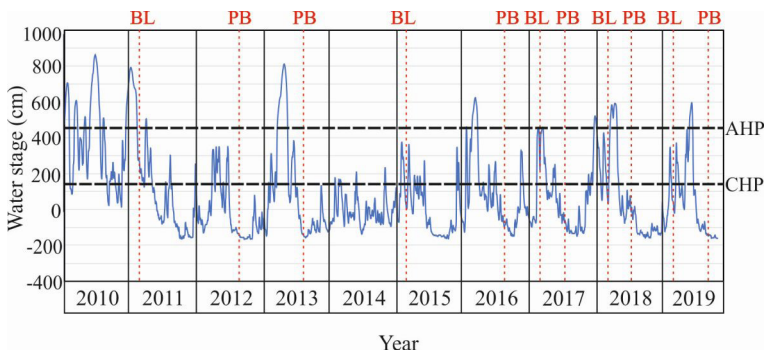
Fig. 2. Daily water stages (2010-2019) measured at the Csongrád gauge station. The survey times of point-bar (PB) and banklines (BL) are indicated. Water stages (dashed lines) when the point-bars at Csongrád (CHP) and Ányás (AHP) are submerged are represented

The changes were related to the daily stage changes at Csongrád gauging station. The upstream point-bar is submerged at 144 cm water stage, while the point-bar at Ányás is covered by much higher (434 cm) stages (Fig. 2).

The hydrological conditions of the studied sections of the Lower Tisza within the studied period is reflected in the water stages from the Csongrád gauge station (Fig. 2). The period (2011-2019) was characterized by mainly low stages (< 0 m), which occurred in 53% of the record (Table 1).

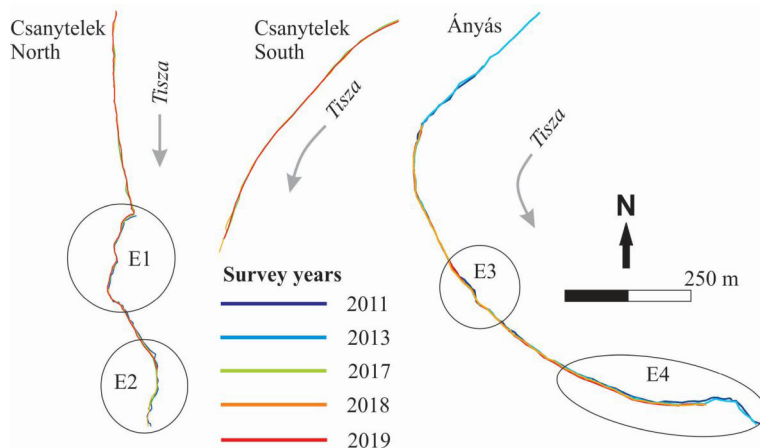
Fig. 3. Changes in banklines at the monitored banks

The bank erosion of the monitored sections of the Lower Tisza River differed both in extent and magnitude (Fig. 3). The bankline experienced minimal erosion at Csanytelek South because of the existence of a revetment, but there was medium erosion rate at Csanytelek North (mean: 0.79 m/y), and high bank retreat was measured at the freely meandering Ányás bend (mean: 1.29 m/y).

and Ányás differed both in magnitude and temporality (Fig. 3-4). The erosion rate gradually increased at Csanytelek North, thus compared to the first period (2015-2017) when the mean erosion rate was 0.56 m/y, it doubled to 1.12 m/y in 2018-2019. The erosion rate (0.67 m/y) in the intermediate period (2017-2018) showed only a slight increase (ca. 20%) compared to the first period. At Ányás, the bank erosion rate had an inverse trend. Between 2011 and 2013 the bank eroded by a high rate (2.75 m/y), the next period (2013-2018) was characterized by 82% reduction in the rate to 0.51 m/y.

Spatially, the erosion rate was quite uniform both at Csanytelek North and Ányás, though some sections were more affected by erosion (E1-4) than the others (Fig. 3). Intense erosion (1.2 m/y) at Csanytelek North occurred at two locations. At E1, bank erosion was initiated by the collapse of the downstream end of the placed-rock revetment. The exposed and steep (ca. 30°) bank then failed through bank scouring, and a mix of failure and slips. At E2, the bank is gentler (ca. 20°) and erosion takes place in

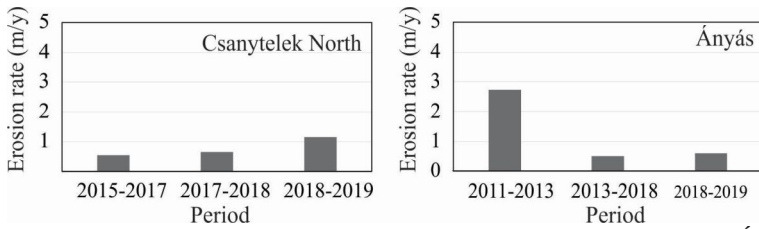
Fig. 4. Annual mean bank erosion rates (m/y) measured at Csanytelek North and Ányás bend

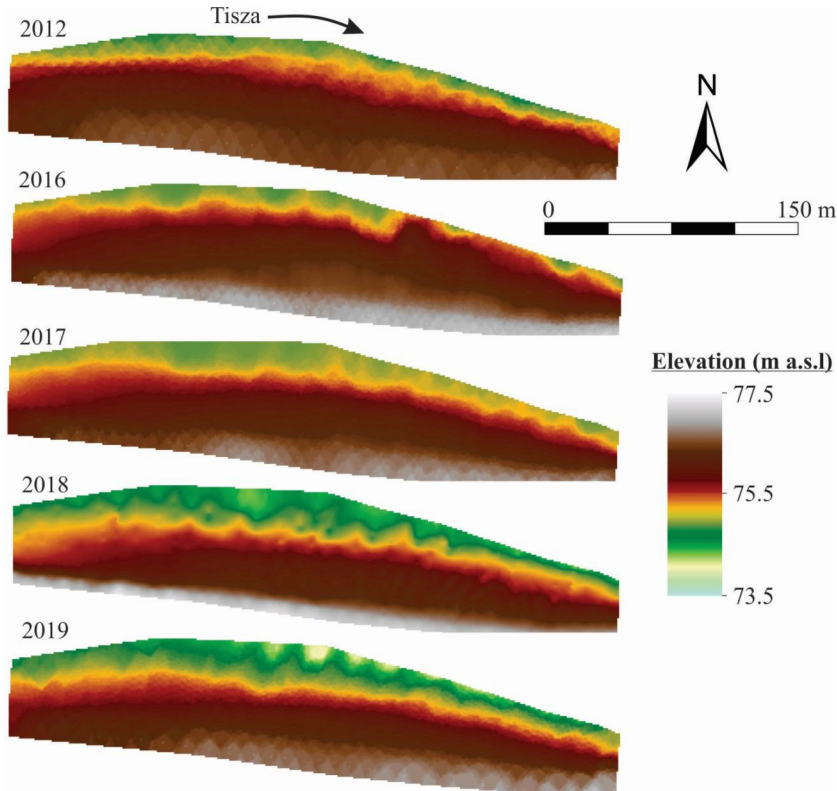
Fig. 5. The digital elevation model of the point-bar at Csongrád in the surveyed years

The point-bar at Csongrád is quite flat (Fig. 5), as its elevation was between 73.5 m a.s.l and 77.5 m a.s.l during the studied period. The volume of the point-bar (above 73.5 m) ranged between 40-47 thousand m³ (Fig. 6). Both the changes in the elevation of the bar surface and its volume reflects the dominance of erosion (Fig. 6-7). The point-bar generally eroded since the first survey in 2012 to 2019, thus the changes in sediment volume refers to net erosion by 9.6 %, thus the volume of sediment decreased by 4260 m³. However, there was net accumulation between 2012 and 2016 (gain: 2338 m³), and again a slight aggradation (87 m³) from 2018 to 2019. However, in-between these years the volume of the bar decreased by 3929 m³ (2016-2017) and later by 2755 m³ (2017-2018). The changes in the sediment volume were translated into changes in the mean elevation

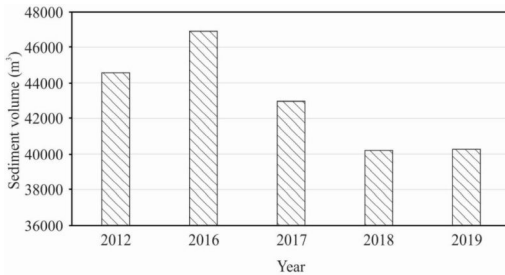
Fig. 6. Sediment volume (above 73.5 m a.s.l.) of the Csongrád point-bar in the surveyed years

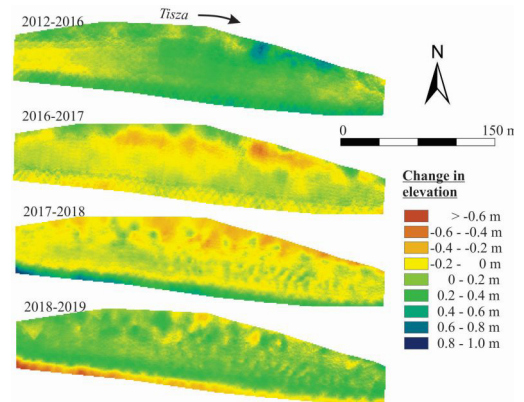
Fig. 7. Elevation changes of the surface of the point-bar at Csongrád. Negative values refer to erosion, positive ones to accumulation

of the point-bar (Fig. 7). In the first period (2012-2016), the aggradation increased the mean elevation of the bar by 0.11 m, especially in the downstream half of the bar, reflecting its slight migration. However, in the subsequent years, the bar became lower by 0.16 m (2016-2017) and further by 0.19 m (2017-2018). Almost the entire area of the bar was eroding, but especially the low-lying areas located close to the wetted channel. Finally, there was a minor increase in the mean elevation (<0.01 m) of the point-bar from 2018 until 2019. At this time, the higher surfaces gained some sediment and the area close to the wetted channel eroded further on.

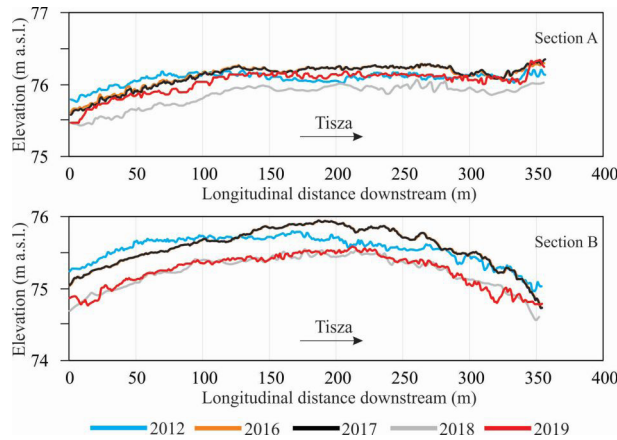
Fig. 8. Spatial and temporal variation of longitudinal profiles (A-B) of the Csongrád point-bar (location of the profiles is indicated in Fig.1)

The spatial and temporal variations of the point-bar at Csongrád are also indicated by the longitudinal and transverse profiles (Figs. 8-9). The longitudinal profiles reflect, that the lower zone (<75.5 m a.s.l.) of the bar had a convex shape, with the middle part having the highest elevation (Fig. 8, section B). The bar surface had quite smooth upstream part, but ripples developed on its downstream part. On both areas there was a generally even erosion, though in the period of 2016-2018, an erosion of almost 1 m took place on the lower regions of the bar. The bar surface was higher (>75.5 m a.s.l.) along the bankline (Fig. 8, section A). Here, the bar had quite smooth surface, with maximum

erosion being generally less than 0.40 m. The greatest was measured on the upstream end, reflecting downstream bar migration. The downstream end had less changes but remained higher than the upstream end although there were fluctuations over the studied period. The transverse profiles reflect that the higher zone of the bar has generally convex slopes (Fig. 9), however the low-lying parts have various slope profiles. While the upstream profile has straight

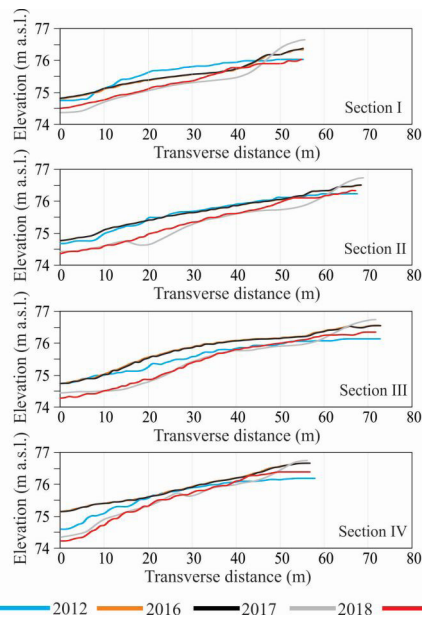
Fig. 9. Spatial and temporal variation of the transverse profiles (I-IV) of the Csongrád point-bar (location of the profiles is indicated in Fig.1)

slope (Fig. 9, Section I), the downstream profiles (Section II-IV) show convex shapes reflecting aggradation processes. The gradual downstream migration of the bar is well visible on these profiles, as Section II had originally a convex profile, but it became straightened, while the further downstream profiles have increasingly convex shape.

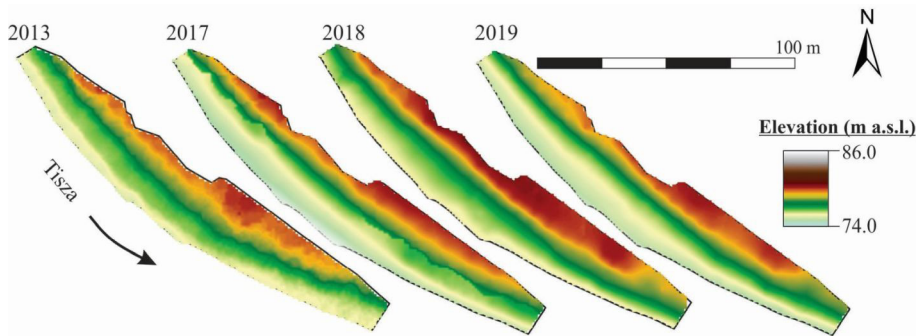
Fig. 10. The digital elevation model of the point-bar at Anyás in the surveyed years

The downstream point-bar at Ányás stretches from 74.0 m a.s.l. to 86.0 m a.s.l. (Fig. 10). The volume of the point-bar (measured

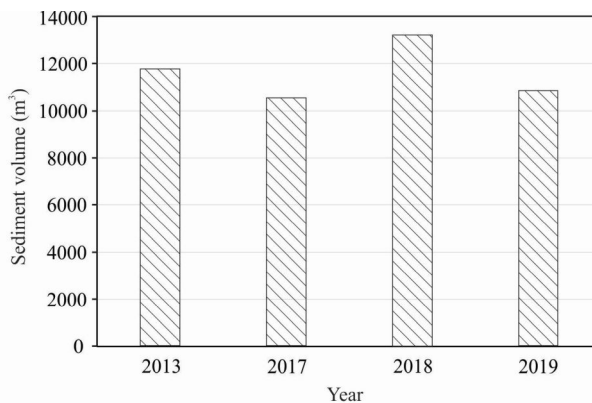
Fig. 11. Sediment volume (above 74.0 m a.s.l.) of the Anyás point-bar in the surveyed years

above 74.0 m a.s.l.) ranged between 10.5–13.3 thousand m³ (Fig. 11), thus its volume is just 20–33% of the point-bar at Csongrád, because it is shorter and narrower than its upstream counterpart. High volumes were measured in 2013 (11747 m³) and in 2018 (13232 m³), though in 2017 and 2019 the volume of the bar decreased to 10517 m³ and 10818 m³ respectively. Thus, the point-bar lost 1230 m³ (2017) and 2414 m³ (2019) of sediments respectively, which means ca. 20% volume lost compared to the previous period. However, in the period of 2017–2018, a similar rate of sediment gain was detected (2715 m³). The changes in sediment volume is reflected also by the pattern of net erosion and net deposition (changes in elevation) between the survey years (Fig. 12). Between 2013 and 2017 the mean height decreased by 0.35 m, especially in three areas: in the near-to-the-bankline zone, and in the middle of the bar, though slight accumulation was detected in its downstream end. The surface became

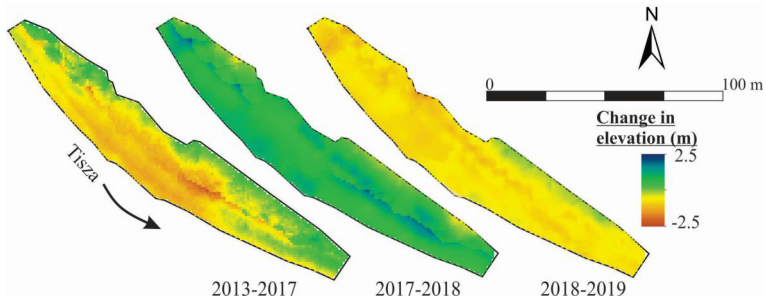
Fig. 12. Elevation changes of the surface of the point-bar at Ányás. Negative values refer to erosion, positive ones to accumulation

higher by 0.76 m in 2017–2018, especially in the upstream parts and close to the water. Finally, the bar's surface became lower by 0.69 m (2018–2019), indicating cyclic erosional-depositional pattern.

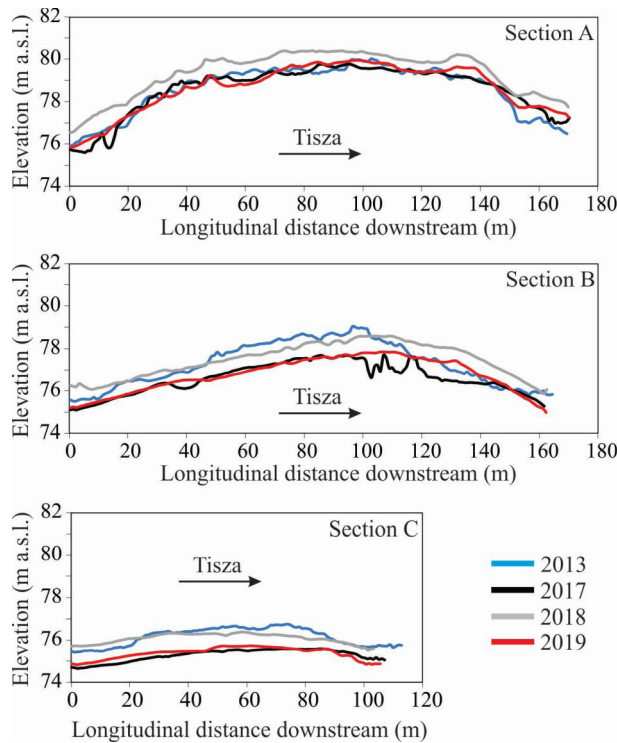
Fig. 13. Spatial and temporal variation of longitudinal profiles (A-C) at the Ányás point-bar (location of the profiles is indicated in Fig.1)

The changes in the height of the bar are further highlighted by the longitudinal and transverse profiles (Fig. 13–14). The cyclic erosion and aggradation of the point-bar involves ca. 1 m change in elevation. The point-bar referred general erosion over the period 2013–2019 especially in its lower zone (<76 m a.s.l.), having a gradual downstream shift in the highest point of the zone (Fig 13: section C). The middle zone (76–78 m a.s.l.) is also characterized by erosion, however there was a slight net aggradation at the downstream end of the bar, and its higher central region also migrated downstream (Fig. 13: section B). The upper surfaces (>78 m a.s.l.) had aggradation at both the downstream and upstream ends of the point-bar (Fig 13: section A).
